HAZARDOUS MATERIALS ASSESSMENT  
REPORT FOR ROCKY MOUNTAIN NATIONAL  
PARK, FALL RIVER ENTRANCE STATION,  
ESTES PARK, COLORADO

PMIS ROMO 160755  
Landmark Project No. 21115.001.001

February 23, 2022

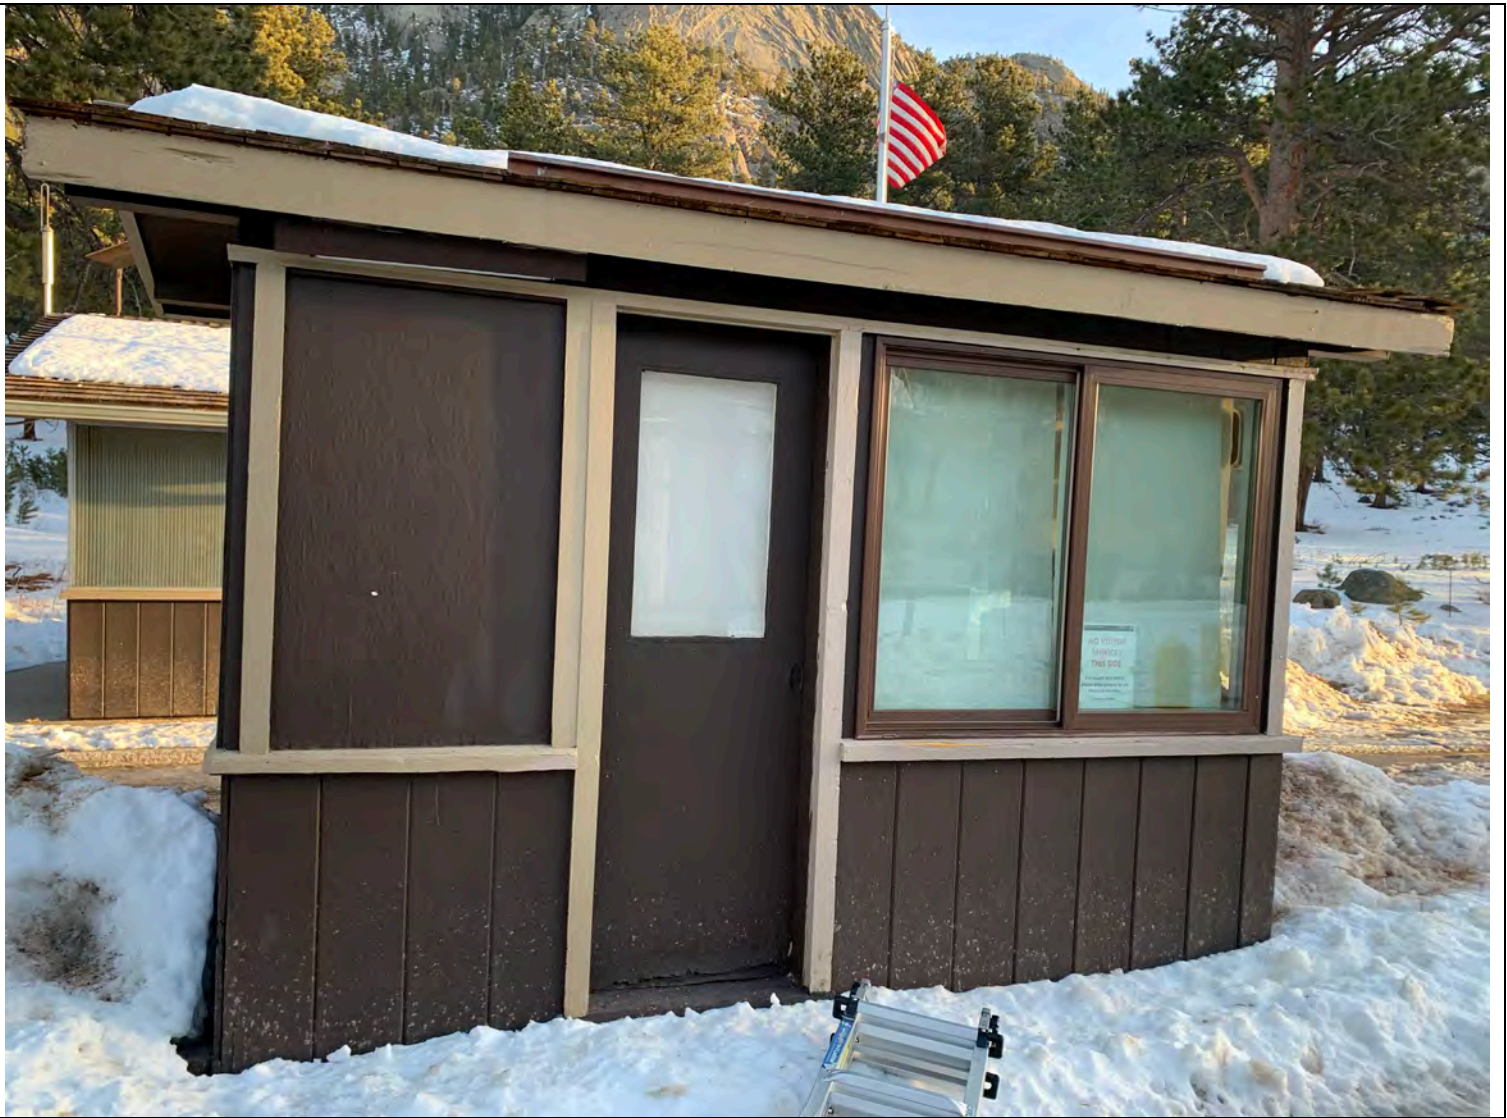
<b>LANDMARK Project No.</b> 21115.001.001	<b>Description</b>	Screening No. 23, Exterior Façade (South), Dark Brown Panel replacing the window, 0.98 mg/cm <sup>2</sup> , Lead Based Paint	<b>Photo 1</b>
	<b>Site Name</b>	Rocky Mountain National Park – Fall River Entrance Station Kiosk 1	<b>Photo Date</b> 01/12/2022

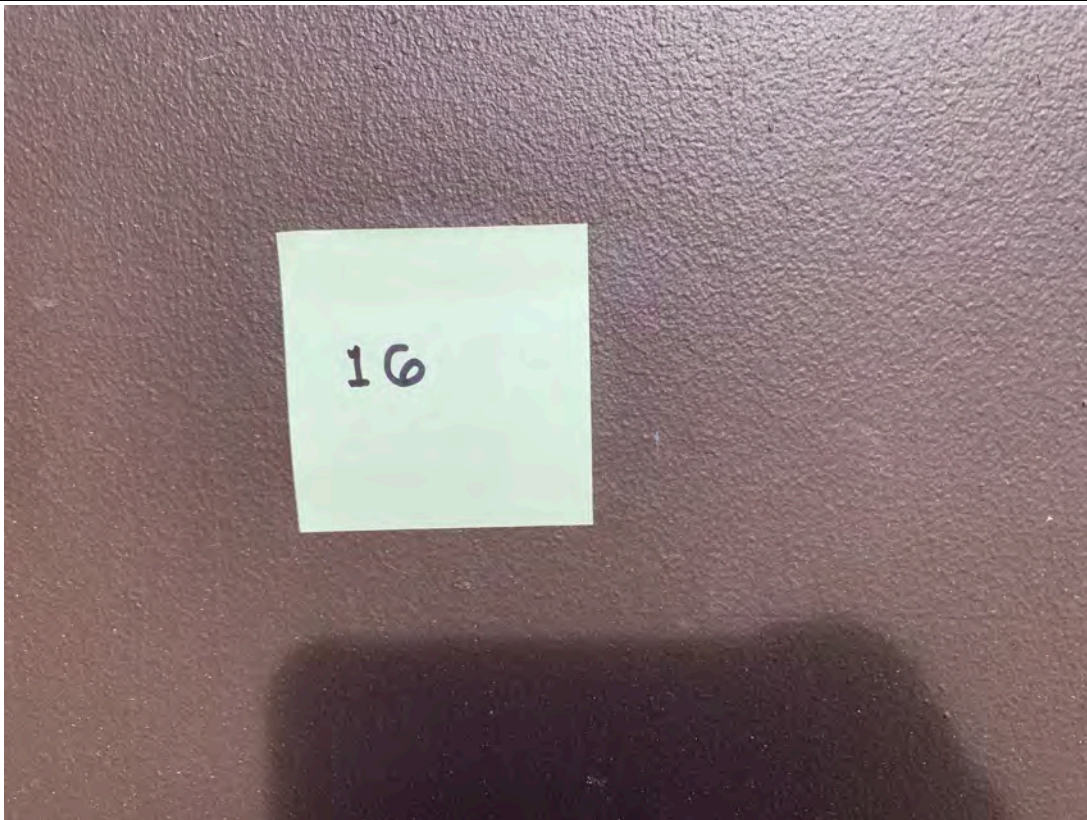
<b>LANDMARK Project No.</b> 21115.001.001	<b>Description</b>	Screening No. 16, Exterior Façade (South), Dark Brown Panel, 2.82 mg/cm <sup>2</sup> , LBP	<b>Photo 2</b>
	<b>Site Name</b>	Rocky Mountain National Park – Fall River Entrance Station Kiosk 2	<b>Photo Date</b> 01/11/2022

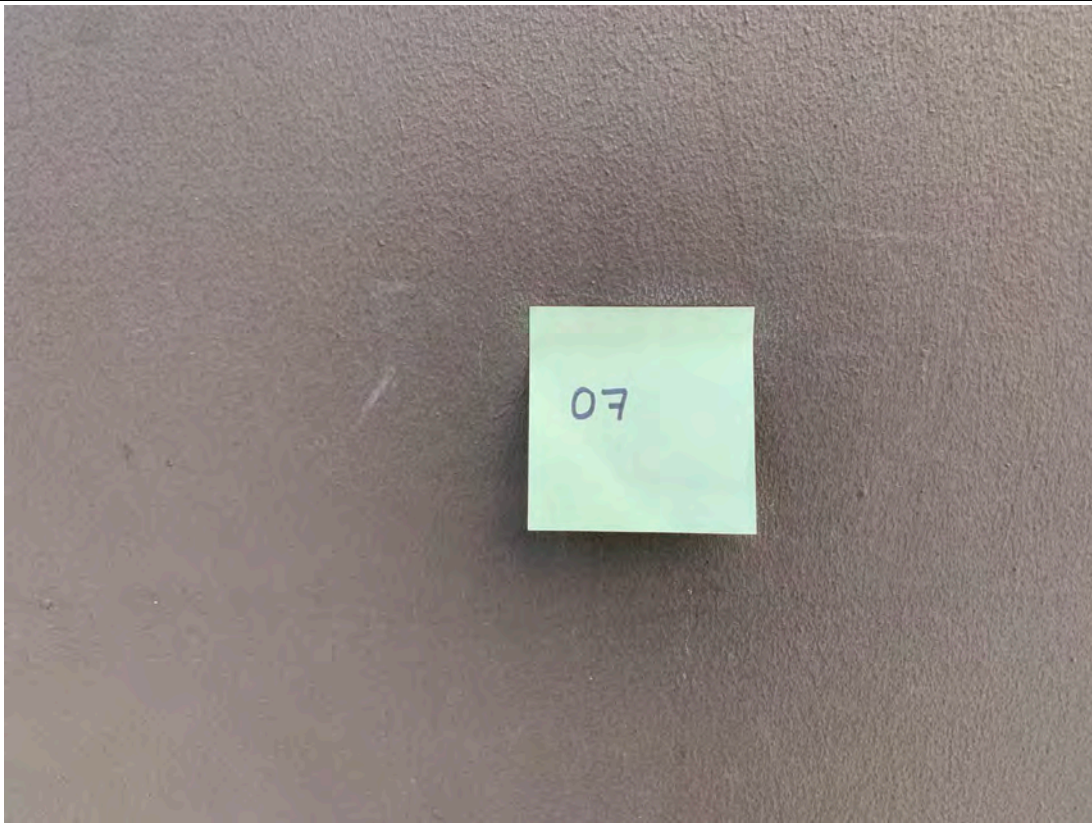
<b>LANDMARK Project No.</b> 21115.001.001	<b>Description</b>	Screening No. 7, Exterior Façade (South), Dark Brown Panel, 0.82 mg/cm <sup>2</sup> , LBP	<b>Photo 2</b>
	<b>Site Name</b>	Rocky Mountain National Park – Fall River Entrance Station Kiosk 3	<b>Photo Date</b> 01/11/2022

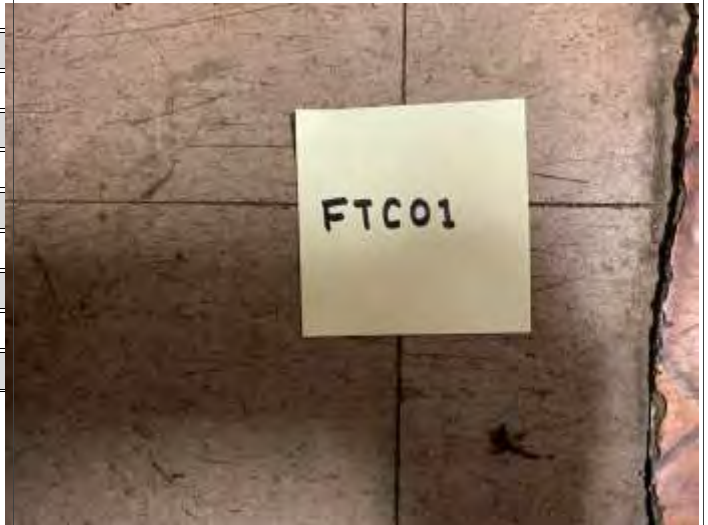
- Floor tile (FTC01): 9-inch by 9-inch tan mottled floor tiles were found to contain between 3 and 5% chrysotile asbestos by PLM analysis. The associated black mastic was identified to be none detect for asbestos via PLM. The FTC01 material is a Category I non-friable material.

SAMPLE NUMBER	SAMPLE LOCATION DESCRIPTION	ANALYTICAL RESULT
O-Closet-FTC01-01	4" from Southeast Corner	Chrysotile 3%
O-Closet-FTC01-02	6" from Southwest Corner	Chrysotile 5%

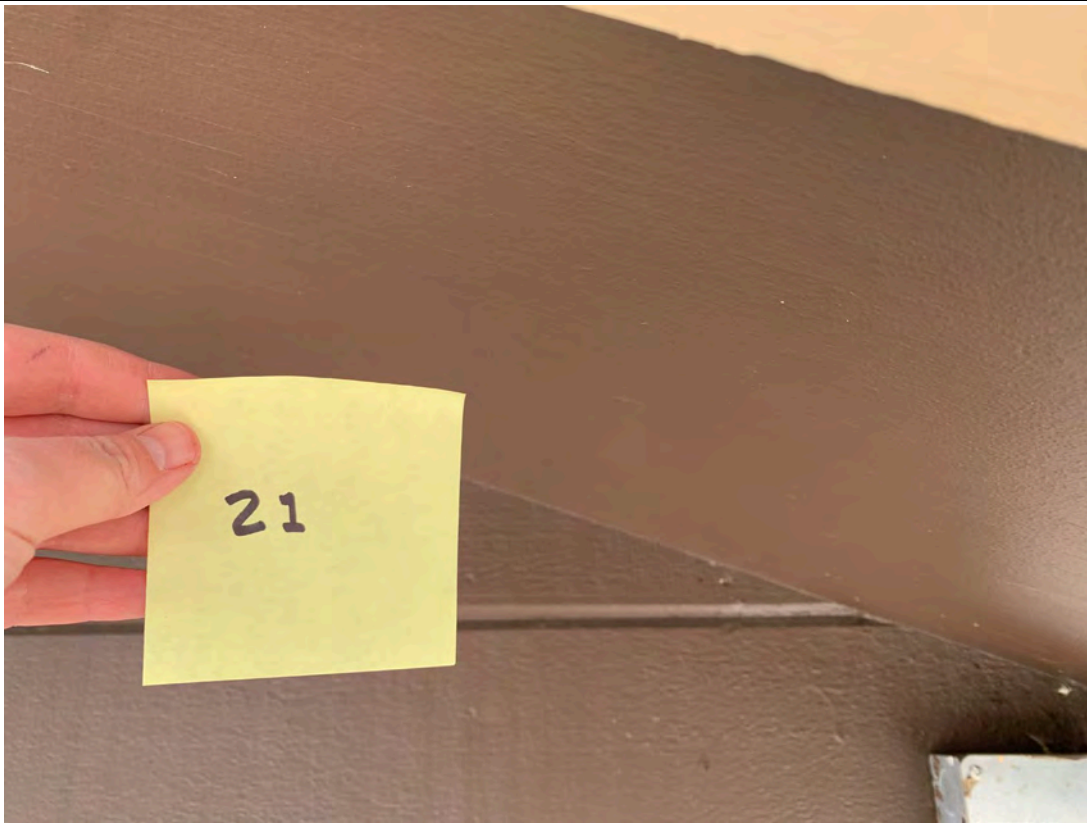
<b>LANDMARK Project No.</b> 21115.001.001	<b>Description</b>	Screening No. 21, Exterior Façade (West), Dark Brown Soffit, 0.81 mg/cm <sup>2</sup> , LBP	<b>Photo 2</b>
	<b>Site Name</b>	Rocky Mountain National Park – Fall River Entrance Station Office	<b>Photo Date</b> 01/12/2022
