Management Report

Air National Guard
Bldg 112
765 n 2200 W, Salt Lake City, UT

Prepared For
Air National Guard

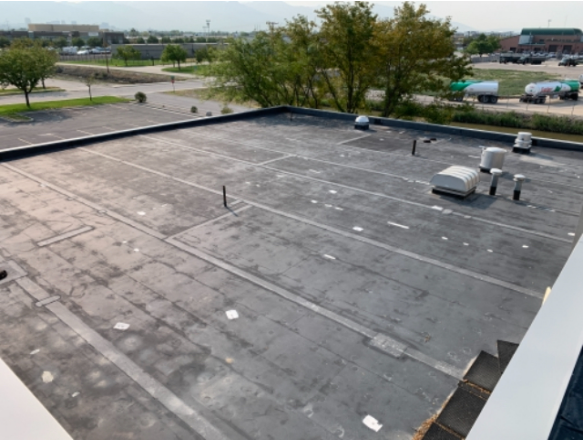
View of Lower EPDM Roof

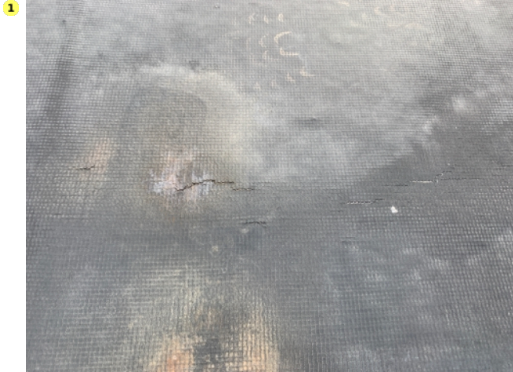
General - Membrane Deterioration (Remedial)

Found many areas of deterioration in the membrane.

This roof is beyond its service life and needs to be replaced.

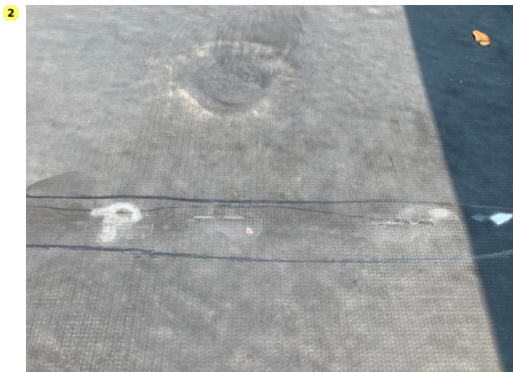
General - Punctures - Rips - Tears (Remedial)

Defect area found allowing water into the roofing system.

This roof is beyond its service life and needs to be replaced.

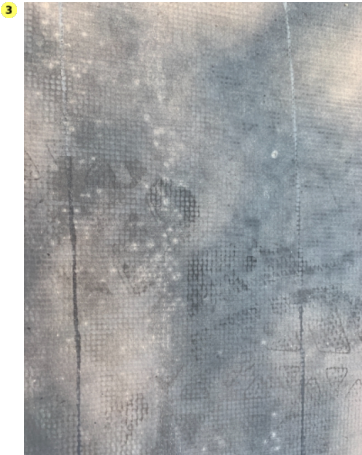
General - Membrane Deterioration (Remedial)

Found area of deterioration in the membrane.

This roof is beyond its service life and needs to be replaced.

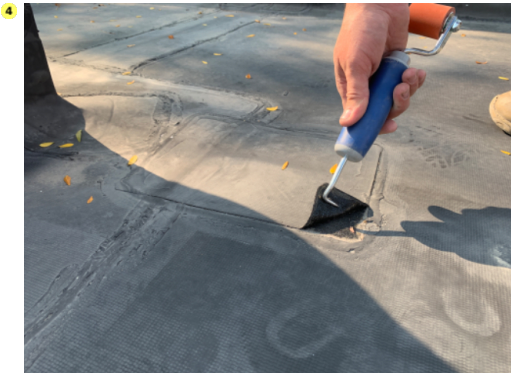
General - Membrane Deterioration (Remedial)

Found area of deteriorating T Patches

This roof is beyond its service life and needs to be replaced.

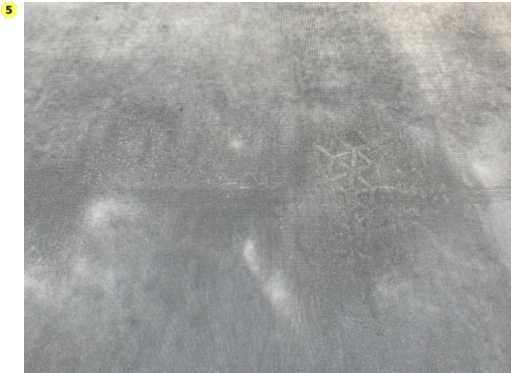
General - Membrane Deterioration (Remedial)

Found many areas of deterioration in the membrane.

This roof is beyond its service life and needs to be replaced.

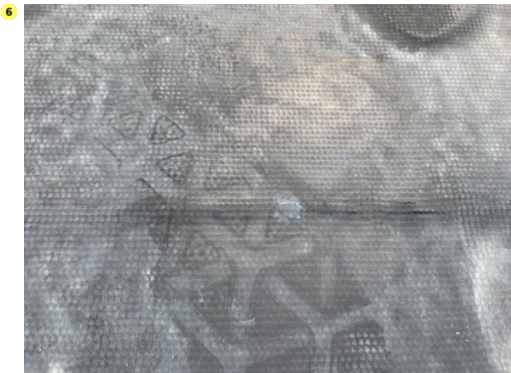
General - Membrane Deterioration (Remedial)

Found area of deterioration in the membrane.

This roof is beyond its service life and needs to be replaced.

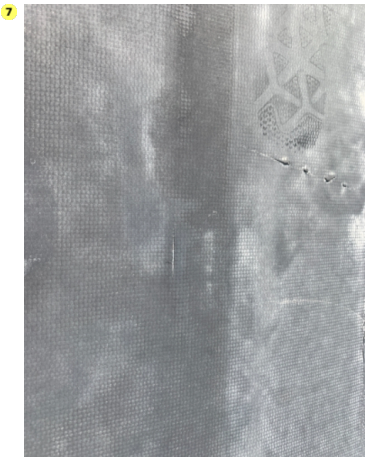
General - Membrane Deterioration (Remedial)
Quantity: 1 EA
Deficiency:
Found area of deterioration in the membrane.
Corrective Action:
This roof is beyond its service life and needs to be replaced.

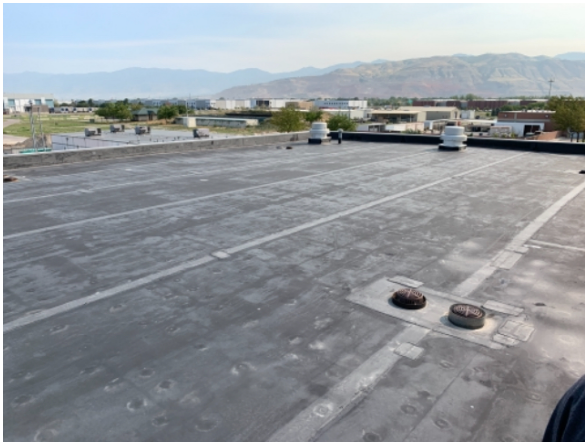
View of north side of upper roof

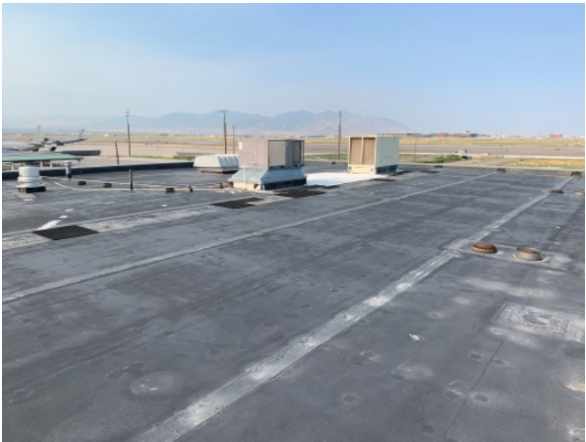
View of south side of upper roof
