# **HAZARDOUS BUILDING MATERIALS INSPECTION REPORT**

## **OFFUTT AFB PROJECT: SGBP 20 -0041 Repair HVAC B 324 Offutt Air Force Base**

**September 4, 2020**

**AMI Environmental**  
8802 South 135<sup>th</sup> Street, Suite 400  
Omaha, Nebraska 68138  
AMIE # 20-205

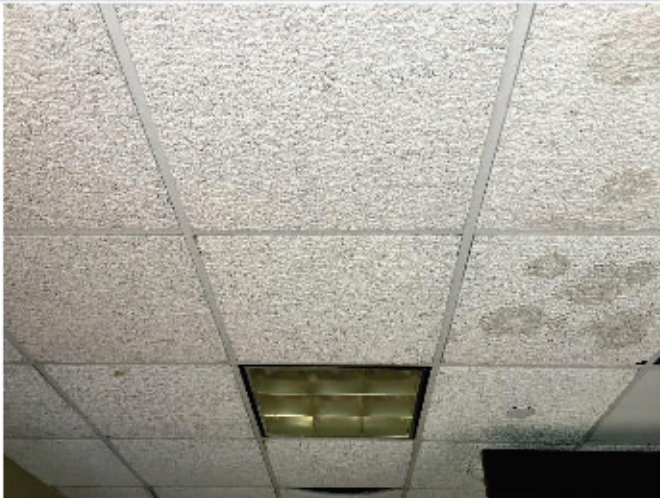
**PHOTO 1** | 2' x 2' Ceiling Tile  
Entry  
Non-ACM

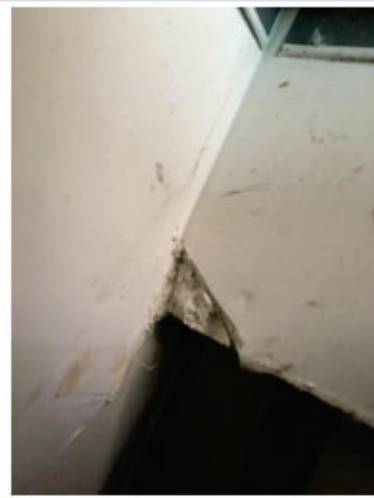
**PHOTO 2** | Drywall Joint Compound  
Atrium  
Non-ACM

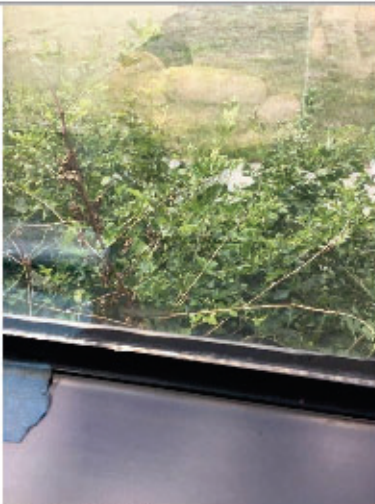
**PHOTO 3** | Black Caulk  
Atrium  
Non-ACM

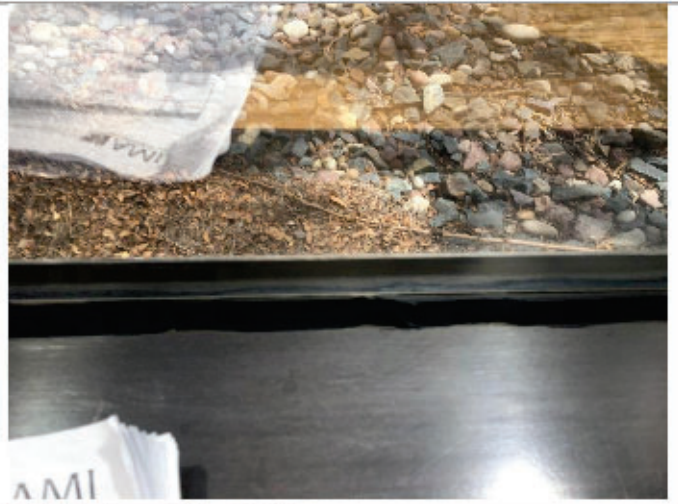
**PHOTO 4** | Black Caulk  
Atrium  
Non-ACM

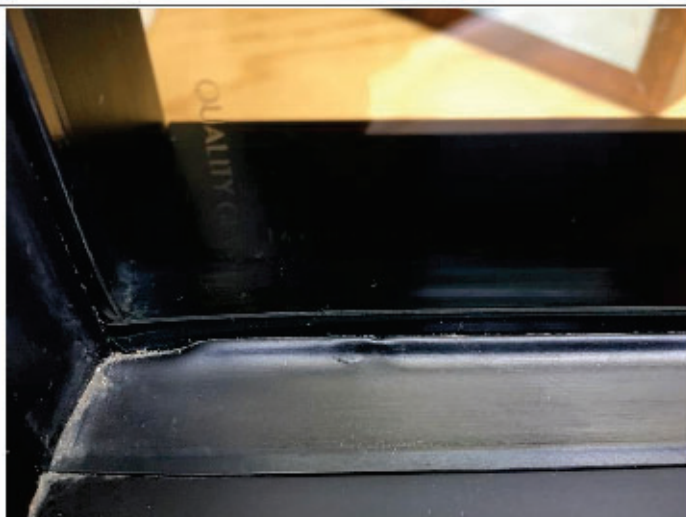
**PHOTO 5** | Black Caulk Interior Windows  
Atrium  
Non-ACM

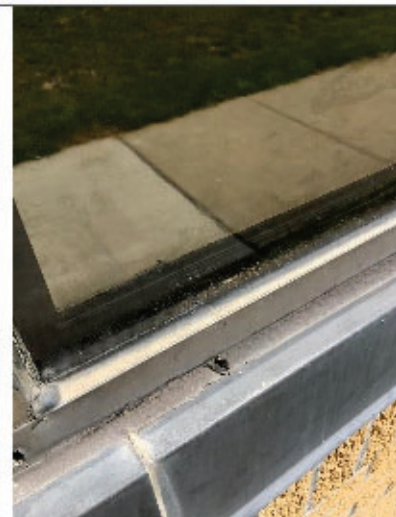
| • Black Exterior Caulk | 3% Chrysotile | 5000 LF |

| Homogeneous Area | Sample No. | Photo No. | Description | Color | Material Location | Asbestos Content | Estimated Quantity | Comments |
|---|---|---|---|---|---|---|---|---|
| 7 | 12 | 6 | Exterior Window Caulk | Black | B 324 Dining Hall Atrium | 3% Chrysotile | 3000 LF | |

**PHOTO 6** | Black Caulk Exterior Windows  
3% Chrysotile

State and/or federal regulations require that ACMs be removed prior to demolition or renovation activities that will impact the ACMs. Depending on the specific renovation work to be performed, certain ACMs, such as the lab sink and countertop, may not require removal if they will not be disturbed and do not pose a risk to building occupants or construction trade workers. However, to ensure worker safety and to eliminate future asbestos-related maintenance and management costs and risks, AMIE recommends removal of all identified ACMs in the areas to be renovated.

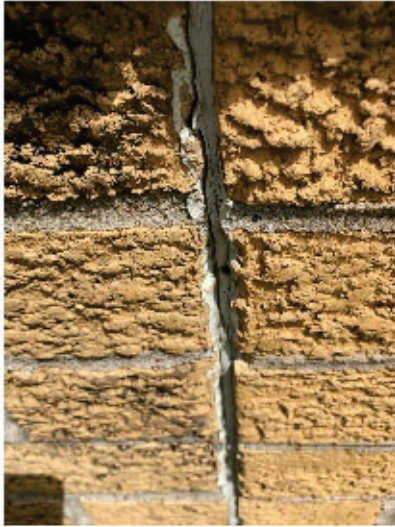
| • Gray Exterior Vertical Seam Caulk | 5% Chrysotile | 500 LF |

| Homogeneous Area | Sample No. | Photo No. | Description | Color | Material Location | Asbestos Content | Estimated Quantity | Comments |
|---|---|---|---|---|---|---|---|---|
| 8 | 14 | 7 | External Vertical Seam Caulk | Gray | B 324 Dining Hall Atrium | 5% Chrysotile | 100 LF | |

**PHOTO 7**      Gray Exterior Vertical Seam Caulk  
5% Chrysotile

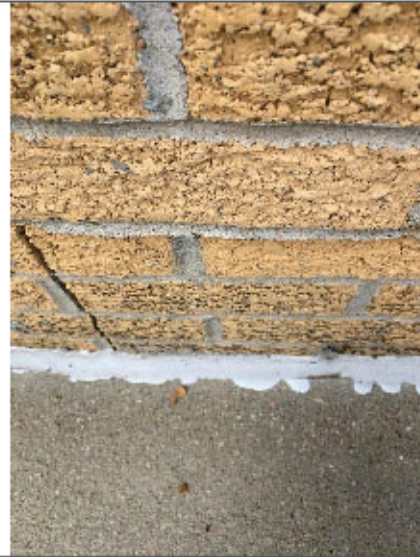
**PHOTO 8**      Gray Base Exterior Caulk  
Non-ACM

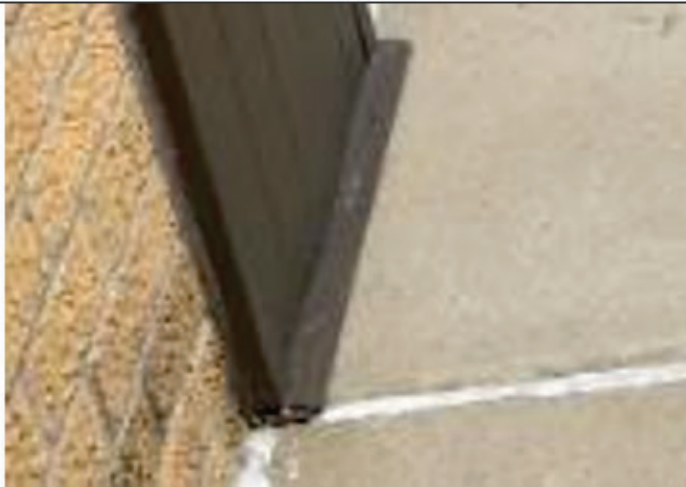
**PHOTO 9**      Black Exterior Base Caulk  
Non-ACM

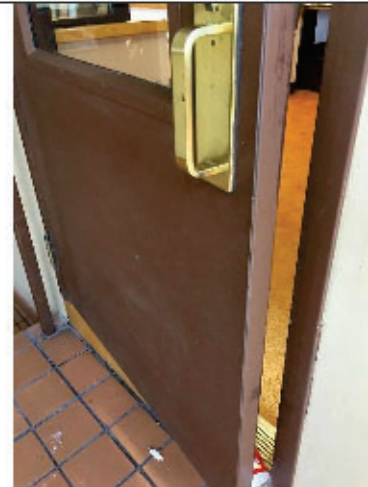
| • Fire Doors | Assumed ACM | 8 EA |

| Homogeneous Area | Sample No. | Photo No. | Description | Color | Material Location | Asbestos Content | Estimated Quantity | Comments |
|---|---|---|---|---|---|---|---|---|
| 11 | | 10 | Fire Doors | Brown | B 324 Dining Hall Atrium | Assumed ACM | 8 EA | |

**PHOTO 10**      Fire Door  
Assumed ACM

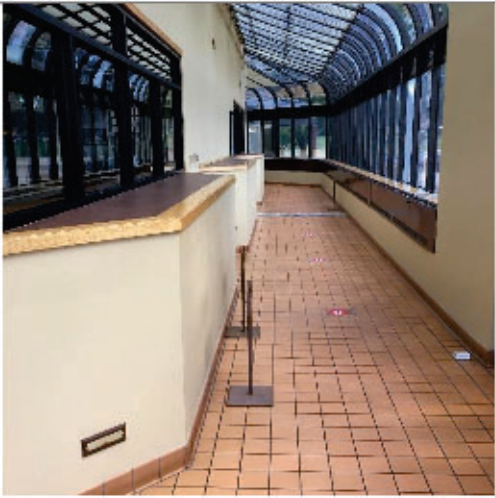
| Sample No. | Photo No. | Substrate | Description | Location | Color | Lead Content % by weight | Condition | Estimated Quantity |
|---|---|---|---|---|---|---|---|---|
| 1 | 1 | Drywall | Painted Walls | B 324 Dining Hall Solarium | Tan | <0.0080 | Fair | |

**PHOTO 1** Tan Painted Walls  
< 0.5% lead (by weight)

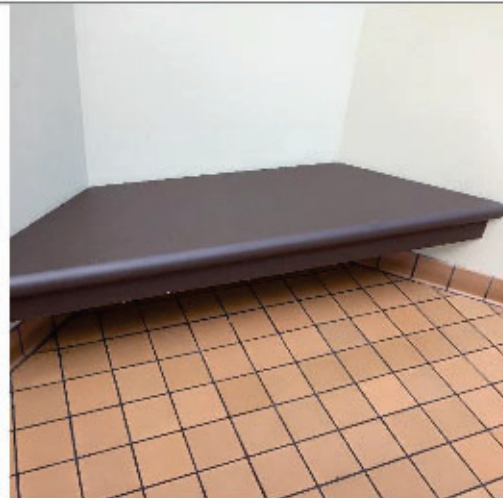
| Sample No. | Photo No. | Substrate | Description | Location | Color | Lead Content % by weight | Condition | Estimated Quantity |
|---|---|---|---|---|---|---|---|---|
| 2 | 2 | Wood | Painted Benches | B 324 Dining Hall Solarium | Brown | <0.0080 | Poor | |

**PHOTO 2** Brown Painted Bench  
< 0.5% lead (by weight)

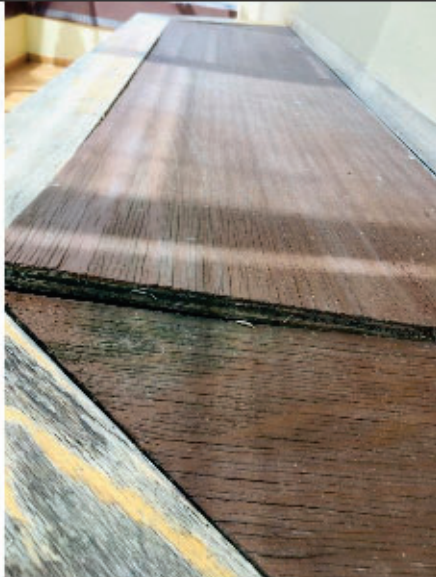
| Sample No. | Photo No. | Substrate | Description | Location | Color | Lead Content % by weight | Condition | Estimated Quantity |
|---|---|---|---|---|---|---|---|---|
| 3 | 3 | Wood | Painted Shelves | B 324 Dining Hall Solarium | Brown | <0.0080 | Fair | |

**PHOTO 3** Brown Painted Shelves  
< 0.5% lead (by weight)

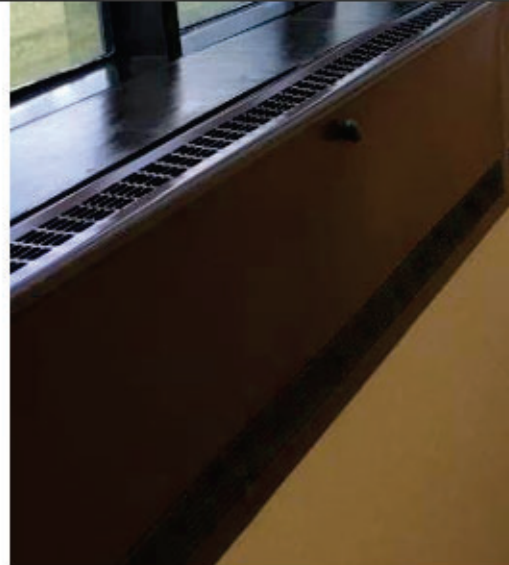
| Sample No. | Photo No. | Substrate | Description | Location | Color | Lead Content % by weight | Condition | Estimated Quantity |
|---|---|---|---|---|---|---|---|---|
| 4 | 4 | Metal | HVAC Wall Units | B 324 Dining Hall Solarium | Brown | 0.32 | Fair | |

**PHOTO 4** Brown Painted HVAC Units  
< 0.5% lead (by weight)

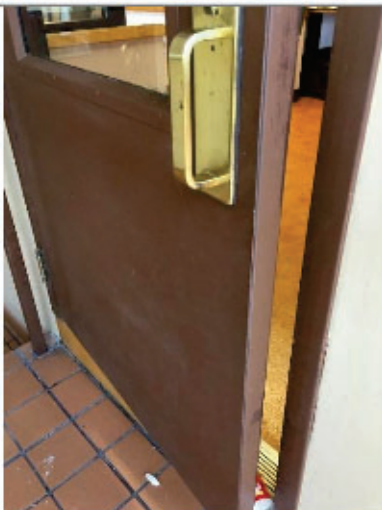
**PHOTO 5** Brown Painted Door  
< 0.5% lead (by weight)

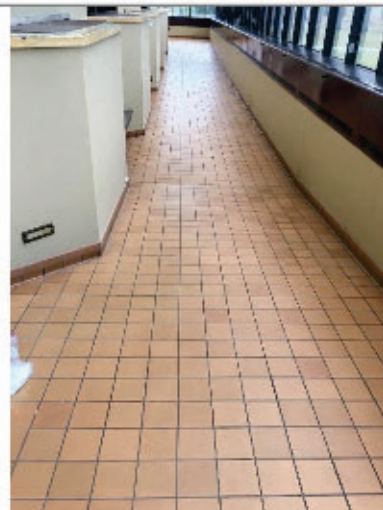
**PHOTO 6** Tan Ceramic Tile Floor  
< 0.5% lead (by weight)

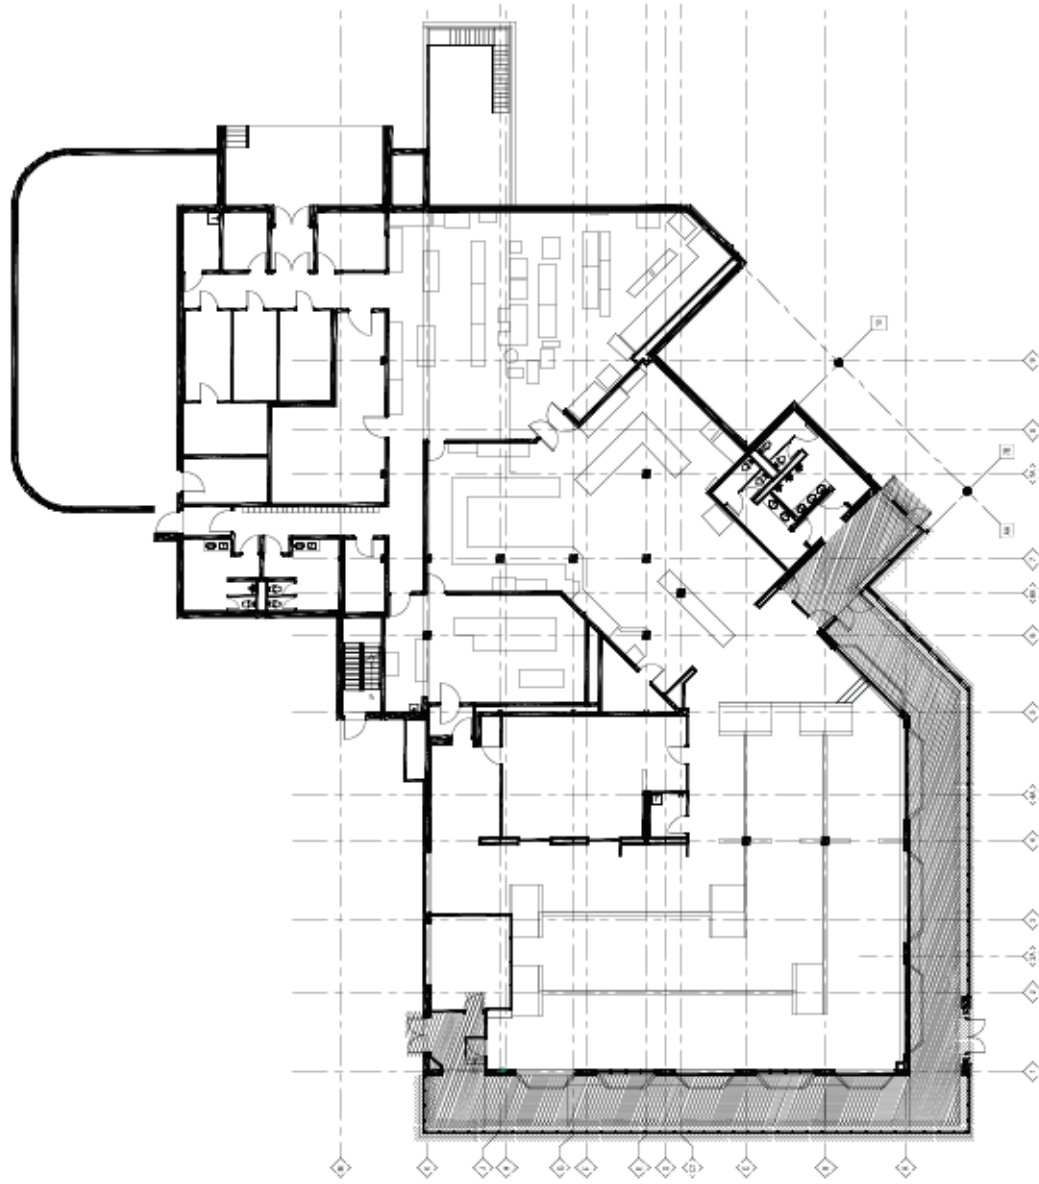
1  
FIRST FLOOR PLAN  
SCALE: 1/8" = 1'-0"

See Appendix D, Schematics, for locations of Asbestos Containing Materials.
