# **HAZARDOUS BUILDING MATERIALS INSPECTION REPORT**

## **OFFUTT AFB PROJECT: SGBP 20-0041 Repair HVAC B 324 - Redesign Offutt Air Force Base**

**November 22, 2022**

## OFFUTT AFB PROJECT: SGBP 20-0041

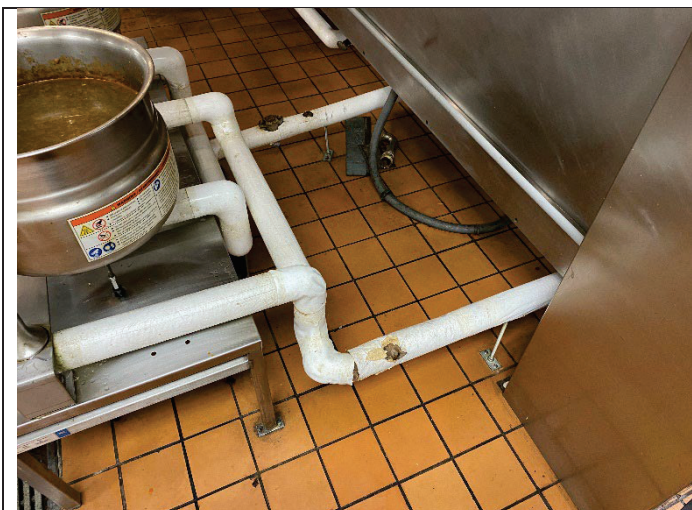
| Material #/<br>Description | Sample<br>ID | Layer ID | Color | Location | Sample Result | Condition | Friable<br>(Y/N) | Estimated<br>Quantity | Photo No. |
|---|---|---|---|---|---|---|---|---|---|
| TSI-01: Fiberglass Pipe<br>Wrap w/ Mastic<br>(White) 2" Pipe | 01<br>02<br>03 | 01<br>02<br>03<br>- Wrap | White/<br>Silver | Kitchen pipes and<br>Attic (HPS, LPS,<br>Condensate) | Non-Detect | | | | 1 |

**PHOTO 1** TSI-01: Fiberglass Pipe Wrap w/ Mastic (White) 2" Pipe

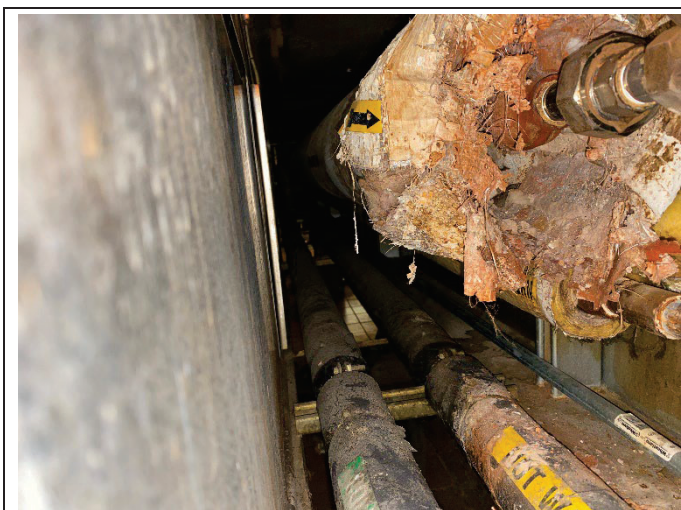
| Material #/<br>Description | Sample<br>ID | Layer ID | Color | Location | Sample Result | Condition | Friable<br>(Y/N) | Estimated<br>Quantity | Photo No. |
|---|---|---|---|---|---|---|---|---|---|
| TSI-02: Fiberglass Pipe<br>Wrap w/ Mastic<br>(White) 4" Pipe | 04<br>05<br>06 | 04<br>05<br>06<br>- Wrap | White/<br>Silver | Kitchen pipes and<br>Attic pipes | Non-Detect | | | | 2 |

**PHOTO 2** TSI-02: Fiberglass Pipe Wrap w/ Mastic (White) 4" Pipe

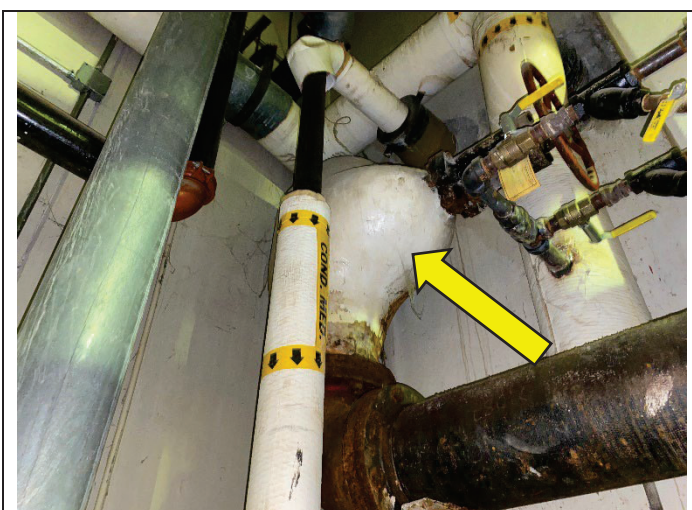
| • Mudded Fittings (Gray/White) | 4% Chrysotile | 3 EA |

| Material #/<br>Description | Sample<br>ID | Layer ID | Color | Location | Sample Result | Condition | Friable<br>(Y/N) | Estimated<br>Quantity | Photo No. |
|---|---|---|---|---|---|---|---|---|---|
| <b>TSI-03: Large<br/>Mudded Fitting<br/>(Gray/White) 2'<br/>Fitting</b> | <b>07<br/>08<br/>09</b> | <b>07<br/>08<br/>09<br/>-Mudded<br/>Fitting</b> | <b>Gray</b> | <b>Basement Southeast<br/>Corner</b> | <b>4% Chrysotile</b> | <b>Good</b> | <b>Y</b> | <b>3 EA</b> | <b>3</b> |

**PHOTO 3** TSI-03: Large Mudded Fitting (4% Chrysotile), and non-ACM wrap.

management costs and risks, AMIE recommends removal of all identified ACMs in the areas to be renovated.

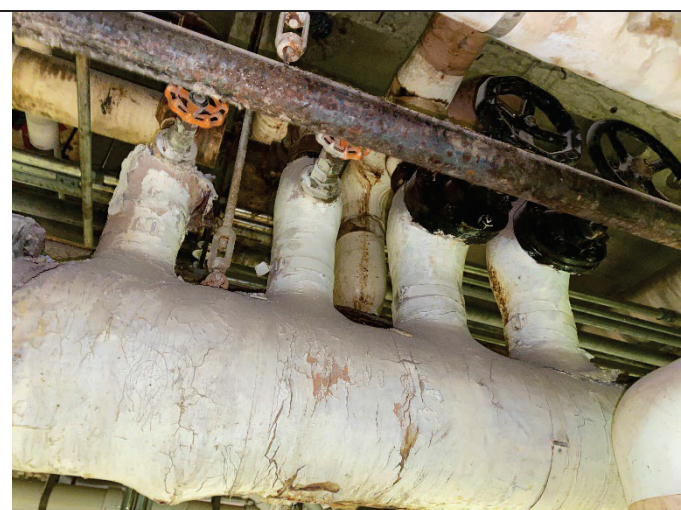
| • Mudded Fittings (White) | 10% Chrysotile/5% Amosite | 12 EA |

**PHOTO 4** TSI-04: 4" Mudded Fittings (White) (5% Amosite and 10% Chrysotile) and non-ACM wrap.

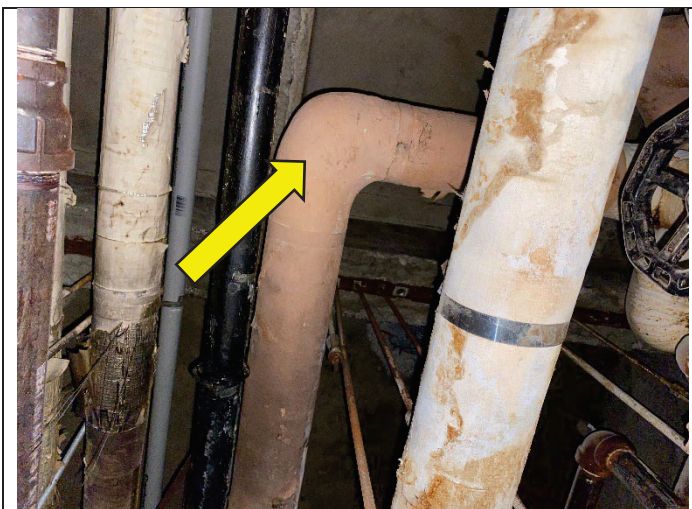
| • Mudded Fittings (Brown/White) | 2% Chrysotile | 6 EA |

**PHOTO 5** TSI-05: 4" Mudded Fittings (Brown/White) (2% Chrysotile) and non-ACM wrap.

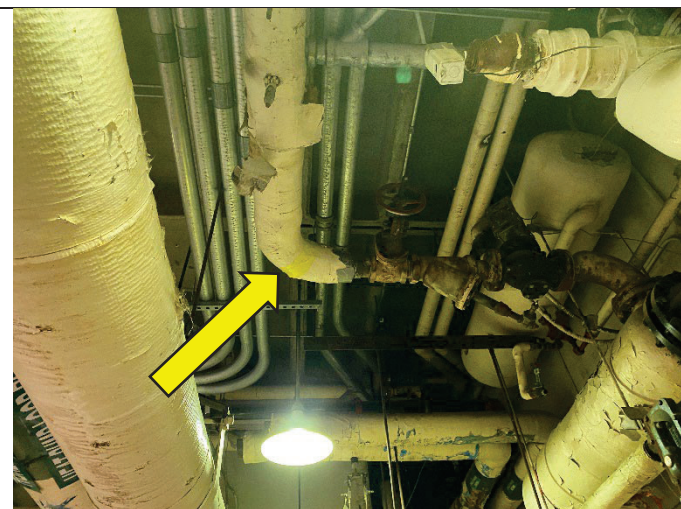
| • Mudded Fittings (Gray) | 5% Chrysotile | 30 EA |

**PHOTO 6** TSI-06: 6" Mudded Fittings (Gray) (5% Chrysotile) and non-ACM wrap.

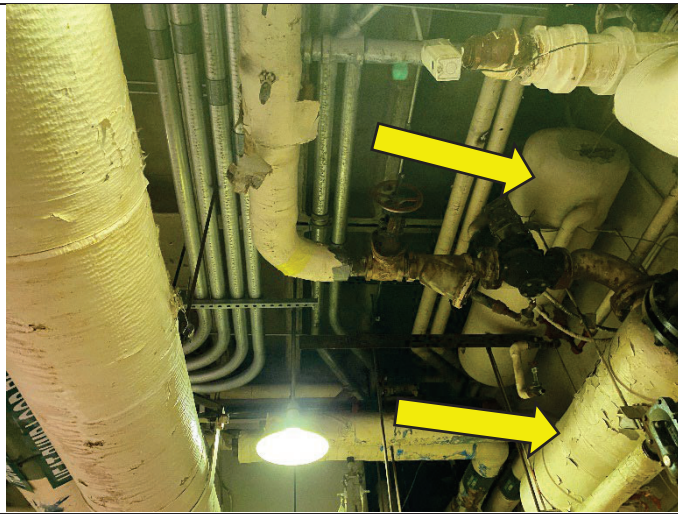
| • Tank Insulation (Gray) | 15% Chrysotile | 225 SF |

**PHOTO 7**      **TSI-07: Insulation (Expansion Tanks) (15% Chrysotile).**

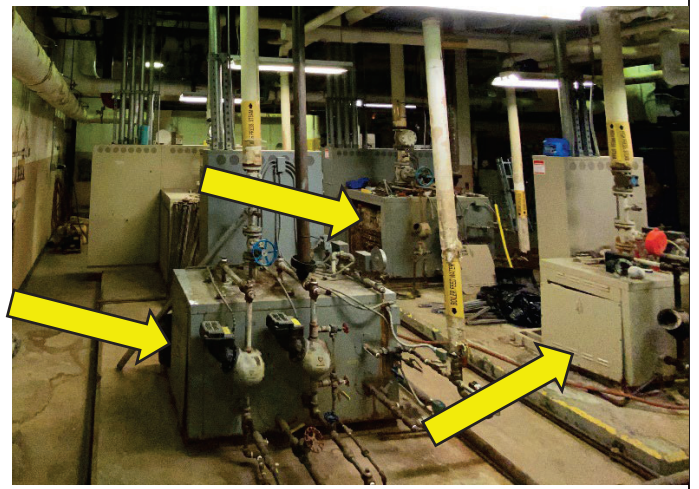
**PHOTO 8**      **TSI-08 Interior Boiler Insulation and filler (<1% Chrysotile).**

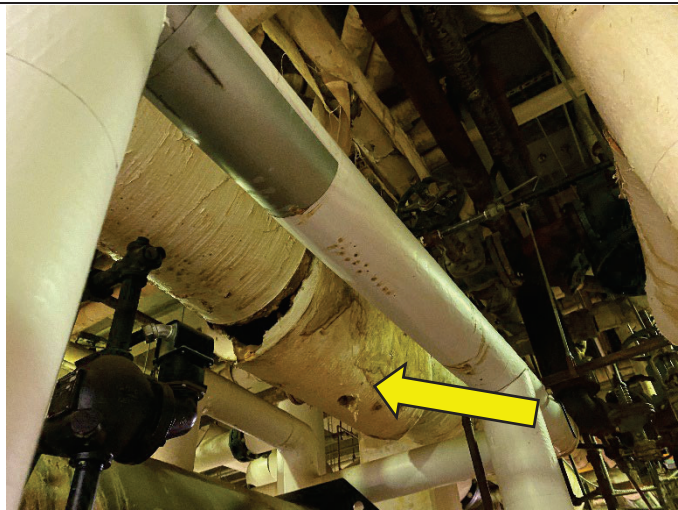
**PHOTO 9**      **TSI-09: 12" Fiberglass Pipe Insulation (HPS) w/ Mastic (White)**

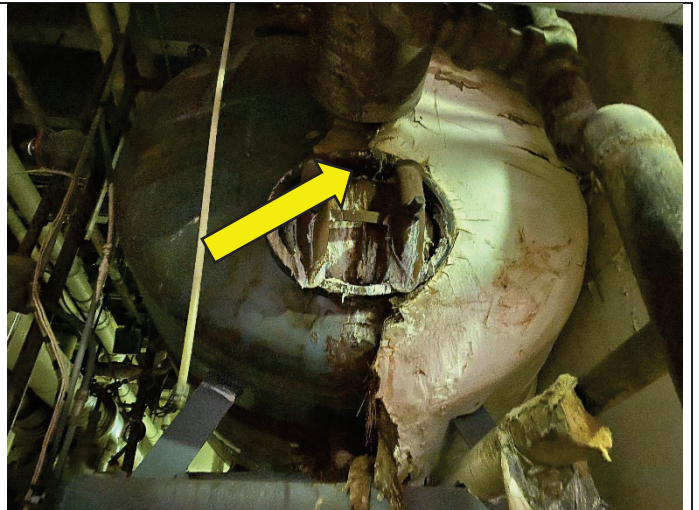
**PHOTO 10**      **MM-01: Gasket, Black.**

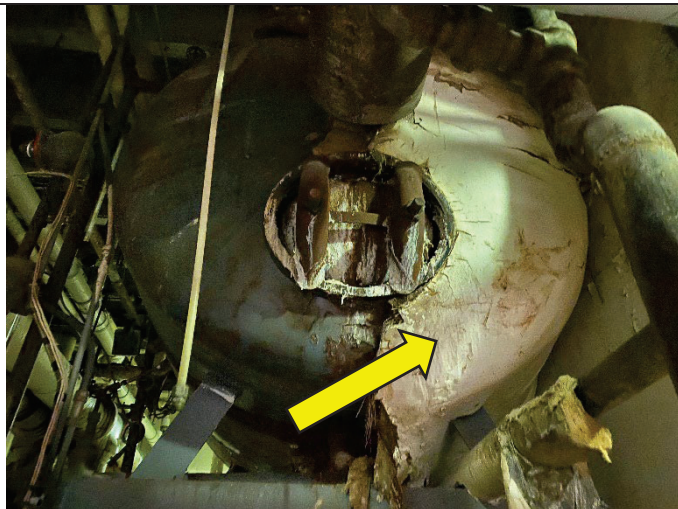
| Material #/<br>Description | Sample<br>ID | Layer ID | Color | Location | Sample Result | Condition | Friable<br>(Y/N) | Estimated<br>Quantity | Photo No. |
|---|---|---|---|---|---|---|---|---|---|
| TSI-10: Tank Wrap<br>(White/Tan) | 29<br>30<br>31 | 29<br>30<br>31 | Tan/<br>White/<br>Rust | Deaerator Tank | Non-Detect | | | | 11 |

**PHOTO 11**      **TSI-10: Tank Wrap (White/Tan)**

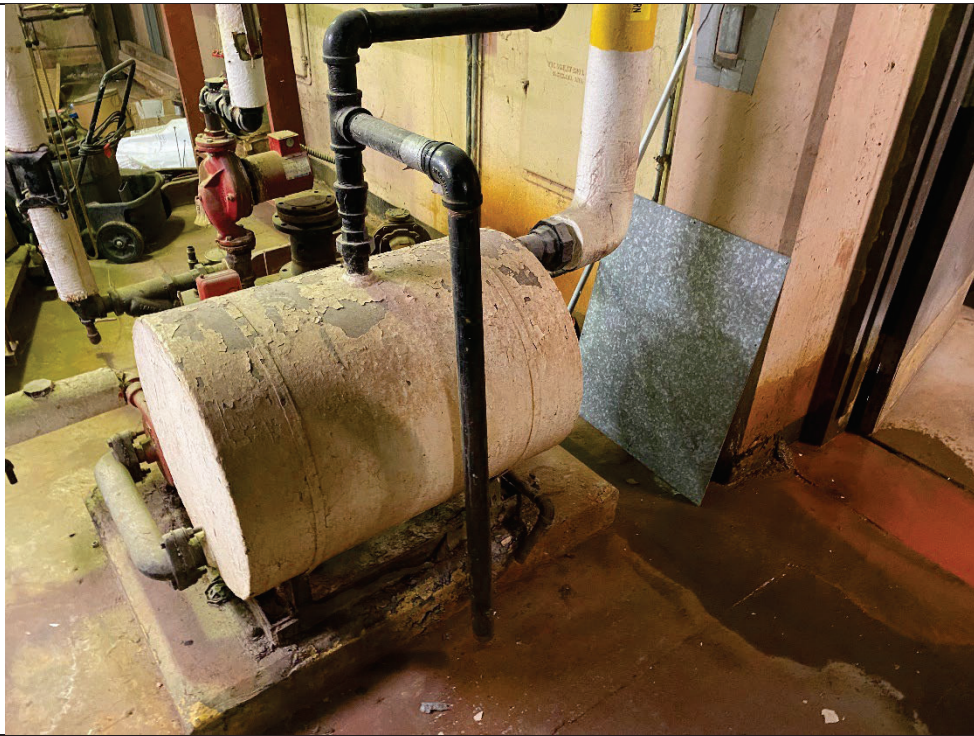
**PHOTO 1**

White on metal Condensate Tank.

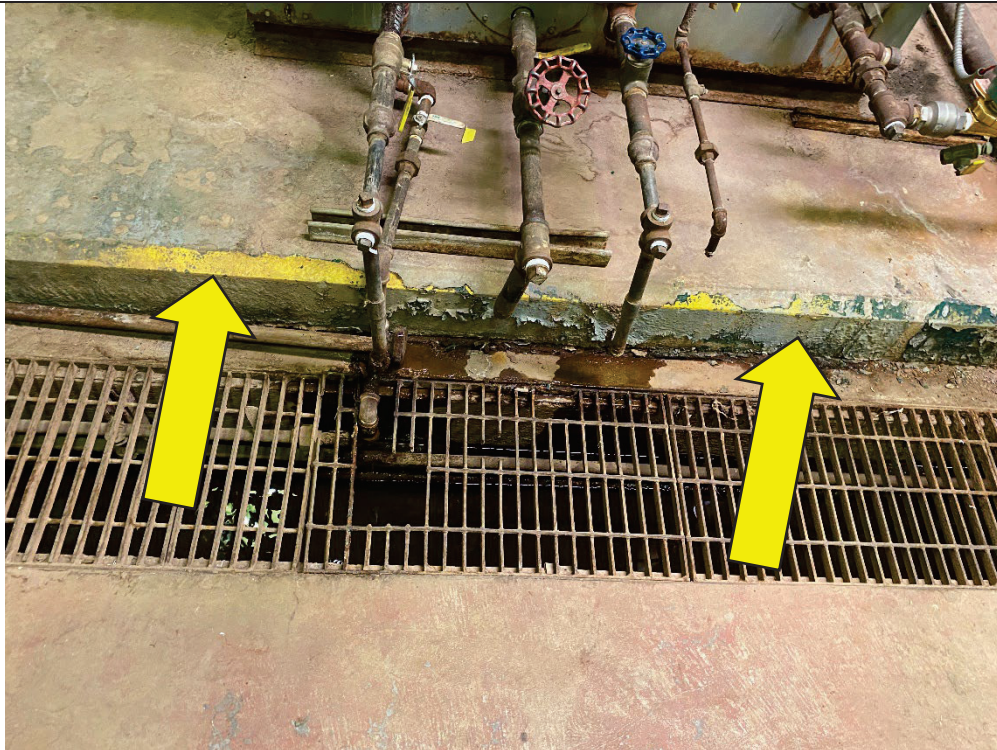
**PHOTO 2**

- Concrete Pad Edge Paint 2.7% Lead by Weight 70 SF
- Paint applications were determined to contain detectable levels of lead. See Section 7.2 for more information on Lead in Construction.

Yellow and Green on Concrete Pad. 2.7% lead by weight.

AMIE recommends TCLP testing be conducted on the existing building materials, painted and unpainted, prior to the start of renovation or demolition activity to document that the waste stream is acceptable for disposal of as non-hazardous waste. In addition, trade contractors who work in the facility should be notified of the presence of paints containing lead so that they can appropriately monitor and protect their workers against lead exposure.
