HAZARDOUS MATERIALS ASSESSMENT  
REPORT FOR ROCKY MOUNTAIN NATIONAL  
PARK, FALL RIVER ENTRANCE STATION,  
ESTES PARK, COLORADO

PMIS ROMO 160755  
Landmark Project No. 21115.001.001

February 23, 2022

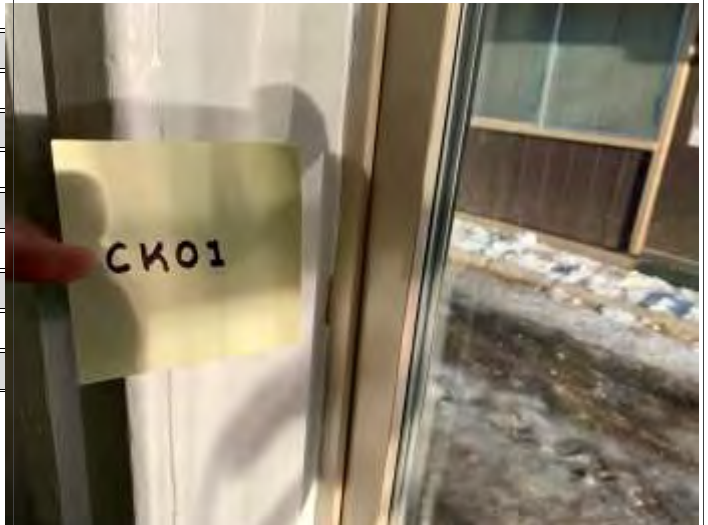
HOMOGENOUS MATERIAL DESCRIPTION		
Caulking (interior/exterior)		
CODE	SEQUENCE	SIZE
CK	01	N/A
COLOR	PATTERN/TEXTURE	ASSOCIATED MAT.
White	Pliable	Interior Windows
QUANTITY	MATERIAL TYPE	FRIABLE
11	M	NF II
CONDITION	DISTURBANCE	ASSESSMENT CAT.
G	L	N/A
MATERIAL NOTES

SAMPLE NUMBER	SAMPLE LOCATION DESCRIPTION	ANALYTICAL RESULT
K1-Interior-CK01-01	North Wall, 5' from West Wall, 3.5' Above Floor	None Detected
K1-Interior-CK01-02	North Wall, 5' from West Wall, 4.5' Above Floor	None Detected

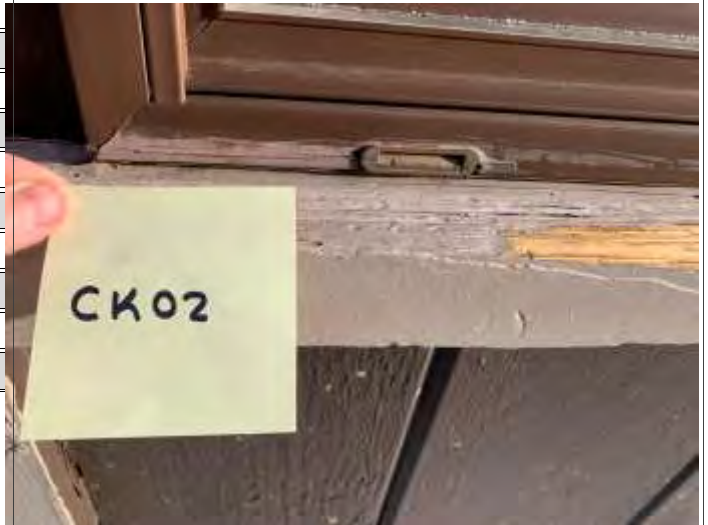
HOMOGENOUS MATERIAL DESCRIPTION		
Caulking (interior/exterior)		
CODE	SEQUENCE	SIZE
CK	02	N/A
COLOR	PATTERN/TEXTURE	ASSOCIATED MAT.
Pink	Pliable	Exterior Façade
QUANTITY	MATERIAL TYPE	FRIABLE
36	M	NF II
CONDITION	DISTURBANCE	ASSESSMENT CAT.
G	L	N/A
MATERIAL NOTES

SAMPLE NUMBER	SAMPLE LOCATION DESCRIPTION	ANALYTICAL RESULT
K1-Exterior-CK02-01	South Wall, 6" from Southeast Corner, 3.5' Above Ground	None Detected
K1-Exterior-CK02-02	South Wall, 3' from Southeast Corner, 3.5' Above Ground	None Detected
K1-Exterior-CK02-03	South Wall, 4.5' from Southeast Corner, 3.5' Above Ground (Quality Control)	None Detected

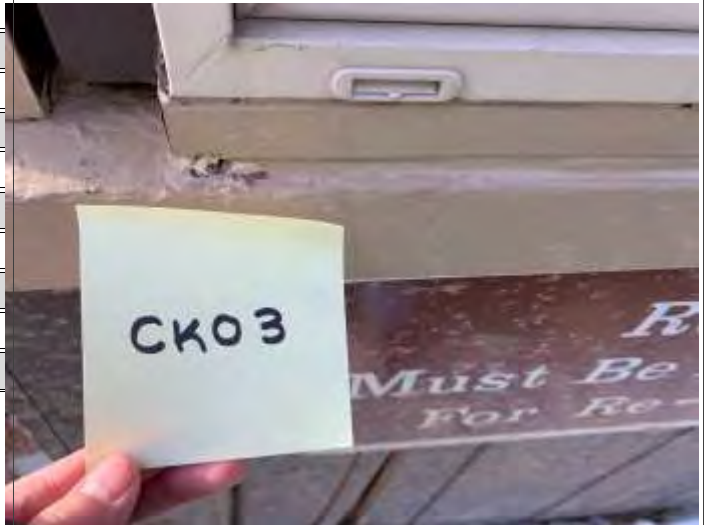
HOMOGENOUS MATERIAL DESCRIPTION		
Caulking (interior/exterior)		
CODE	SEQUENCE	SIZE
CK	03	N/A
COLOR	PATTERN/TEXTURE	ASSOCIATED MAT.
White	Pliable	Exterior Façade
QUANTITY	MATERIAL TYPE	FRIABLE
12	M	NF II
CONDITION	DISTURBANCE	ASSESSMENT CAT.
G	L	N/A
MATERIAL NOTES

SAMPLE NUMBER	SAMPLE LOCATION DESCRIPTION	ANALYTICAL RESULT
K1-Exterior-CK03-01	North Wall, 6" from Northeast Corner, 3.5' Above Ground	None Detected
K1-Exterior-CK03-02	North Wall, 4' from Northeast Corner, 3.5' Above Ground	None Detected

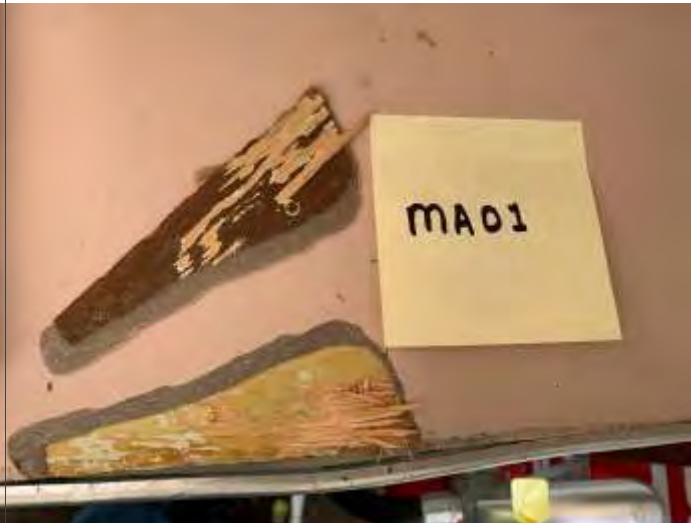
HOMOGENOUS MATERIAL DESCRIPTION		
Adhesive/Mastic, Misc.		
CODE	SEQUENCE	SIZE
MA	01	N/A
COLOR	PATTERN/TEXTURE	ASSOCIATED MAT.
Yellow		Pink Countertop
QUANTITY	MATERIAL TYPE	FRIABLE
20	M	NF II
CONDITION	DISTURBANCE	ASSESSMENT CAT.
G	L	N/A
MATERIAL NOTES

SAMPLE NUMBER	SAMPLE LOCATION DESCRIPTION	ANALYTICAL RESULT
K1-Interior-MA01-01	West Countertop, 1' from North Wall, 2.3' from West Wall, 3.5' Above Floor	None Detected
K1-Interior-MA01-02	East Countertop, 6" from South Wall, 2.5' from East Wall, 3.5' Above Floor	None Detected

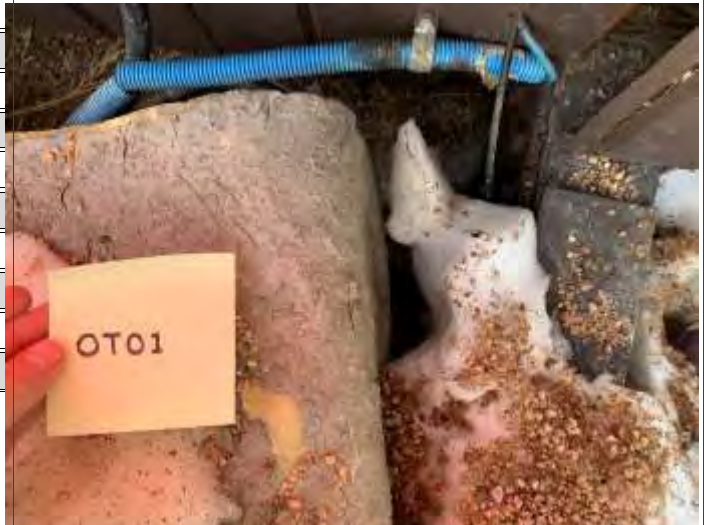
HOMOGENOUS MATERIAL DESCRIPTION		
OTHER		
CODE	SEQUENCE	SIZE
OT	01	N/A
COLOR	PATTERN/TEXTURE	ASSOCIATED MAT.
White Compound	Woven Fabric	Exterior
QUANTITY	MATERIAL TYPE	FRIABLE
20	M	F
CONDITION	DISTURBANCE	ASSESSMENT CAT.
G	L	N/A
MATERIAL NOTES

SAMPLE NUMBER	SAMPLE LOCATION DESCRIPTION	ANALYTICAL RESULT
K1-Exterior-OT01-01	East Exterior, 1' from Northeast Corner, 1' Above Ground	None Detected
K1-Exterior-OT01-02	East Exterior, 2.5' from Northeast Corner, 1' Above Ground	None Detected

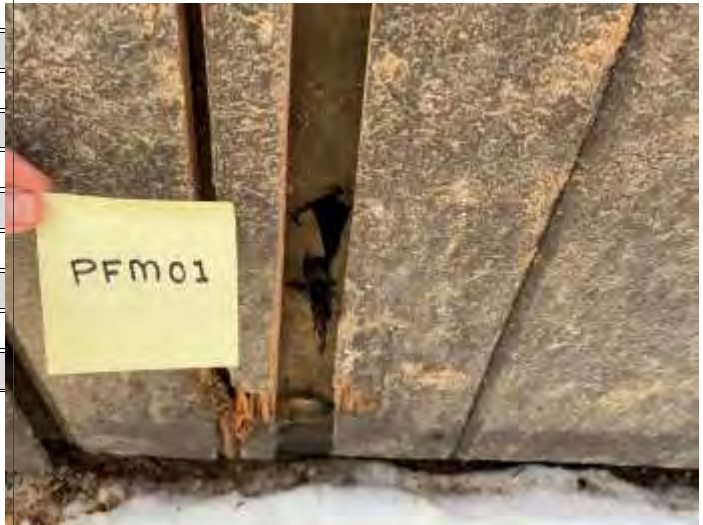
HOMOGENOUS MATERIAL DESCRIPTION		
Paper/Felt, Misc.		
CODE	SEQUENCE	SIZE
PFM	01	N/A
COLOR	PATTERN/TEXTURE	ASSOCIATED MAT.
Brown Black		Exterior Façade
QUANTITY	MATERIAL TYPE	FRIABLE
360	M	F
CONDITION	DISTURBANCE	ASSESSMENT CAT.
G	L	N/A
MATERIAL NOTES

SAMPLE NUMBER	SAMPLE LOCATION DESCRIPTION	ANALYTICAL RESULT
K1-Exterior-PFM01-01	North Wall, 1.5' from Northwest Corner, 1' Above Ground	None Detected
K1-Exterior-PFM01-02	North Wall, 2' from Northwest Corner, 2.5' Above Ground	None Detected

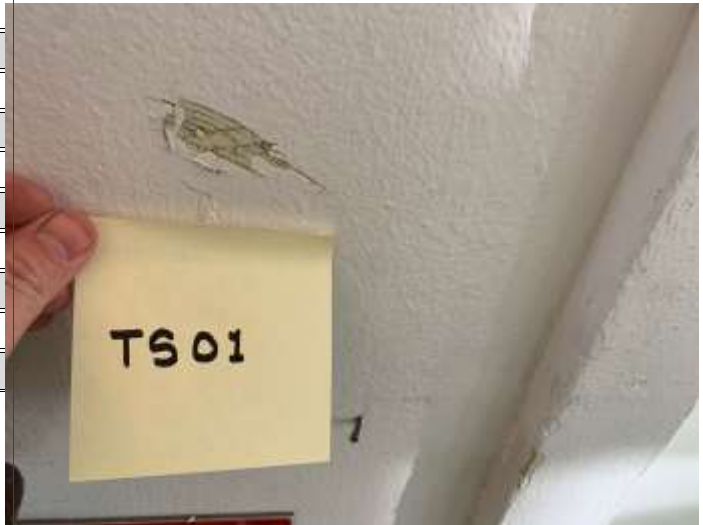
HOMOGENOUS MATERIAL DESCRIPTION		
Textured Surfacing		
CODE	SEQUENCE	SIZE
TS	01	N/A
COLOR	PATTERN/TEXTURE	ASSOCIATED MAT.
White Compound		Wooden Walls
QUANTITY	MATERIAL TYPE	FRIABLE
311	S	F
CONDITION	DISTURBANCE	ASSESSMENT CAT.
G	L	N/A
MATERIAL NOTES

SAMPLE NUMBER	SAMPLE LOCATION DESCRIPTION	ANALYTICAL RESULT
K1-Interior-TS01-01	South Wall, 3' from West Wall, 4.5' Above Floor	None Detected
K1-Interior-TS01-02	North Wall, 3' from West Wall, 2.5' Above Floor	None Detected
K1-Interior-TS01-03	North Wall, 6' from West Wall, 2' Above Floor	None Detected

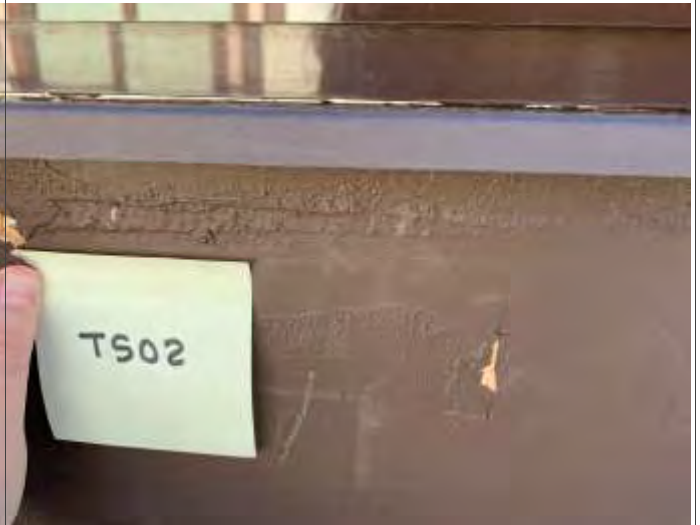
HOMOGENOUS MATERIAL DESCRIPTION		
Textured Surfacing		
CODE	SEQUENCE	SIZE
TS	02	N/A
COLOR	PATTERN/TEXTURE	ASSOCIATED MAT.
White Compound	Woven Cloth	Signage Board
QUANTITY	MATERIAL TYPE	FRIABLE
2	S	F
CONDITION	DISTURBANCE	ASSESSMENT CAT.
G	L	N/A
MATERIAL NOTES

SAMPLE NUMBER	SAMPLE LOCATION DESCRIPTION	ANALYTICAL RESULT
K1-Exterior-TS02-01	North Wall, 2' from Northwest Corner, 4.5' Above Ground	None Detected
K1-Exterior-TS02-02	North Wall, 2.5' from Northwest Corner, 4.5' Above Ground	None Detected
K1-Exterior-TS02-03	North Wall, 3' from Northwest Corner, 4.5' Above Ground	None Detected

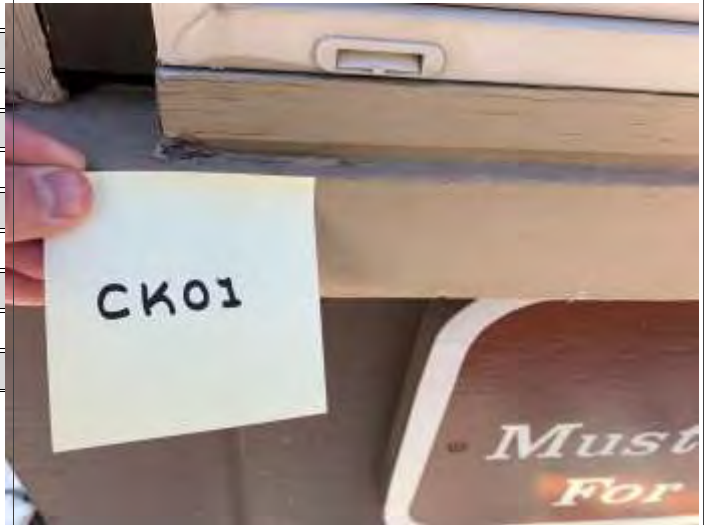
HOMOGENOUS MATERIAL DESCRIPTION		
Caulking (interior/exterior)		
CODE	SEQUENCE	SIZE
CK	01	N/A
COLOR	PATTERN/TEXTURE	ASSOCIATED MAT.
Pink	Pliable	Exterior Window
QUANTITY	MATERIAL TYPE	FRIABLE
20	M	NF II
CONDITION	DISTURBANCE	ASSESSMENT CAT.
G	L	N/A
MATERIAL NOTES

SAMPLE NUMBER	SAMPLE LOCATION DESCRIPTION	ANALYTICAL RESULT
K2-Exterior-CK01-01	North Wall, 1' from Northeast Corner, 3' Above Ground	None Detected
K2-Exterior-CK01-02	North Wall, 5' from Northwest Corner, 3' Above Ground	None Detected

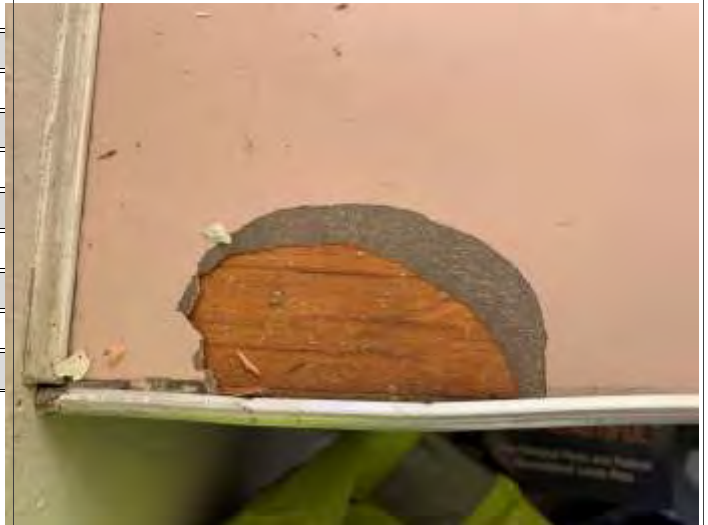
HOMOGENOUS MATERIAL DESCRIPTION		
Adhesive/Mastic, Misc.		
CODE	SEQUENCE	SIZE
MA	01	N/A
COLOR	PATTERN/TEXTURE	ASSOCIATED MAT.
Clear Brown		Pink Countertop
QUANTITY	MATERIAL TYPE	FRIABLE
20	M	NF II
CONDITION	DISTURBANCE	ASSESSMENT CAT.
G	L	N/A
MATERIAL NOTES

SAMPLE NUMBER	SAMPLE LOCATION DESCRIPTION	ANALYTICAL RESULT
K2-Interior-MA01-01	West Countertop, 6" from South Wall, 3' from West Wall, 3.5' Above Floor	None Detected
K2-Interior-MA01-02	East Countertop, 6" from South Wall, 3' From East Wall, 3.5' Above Floor	None Detected
K2-Interior-MA01-03	West Countertop, 6" from South Wall, 3' from West Wall, 3.5' Above Floor (Quality Control)	None Detected

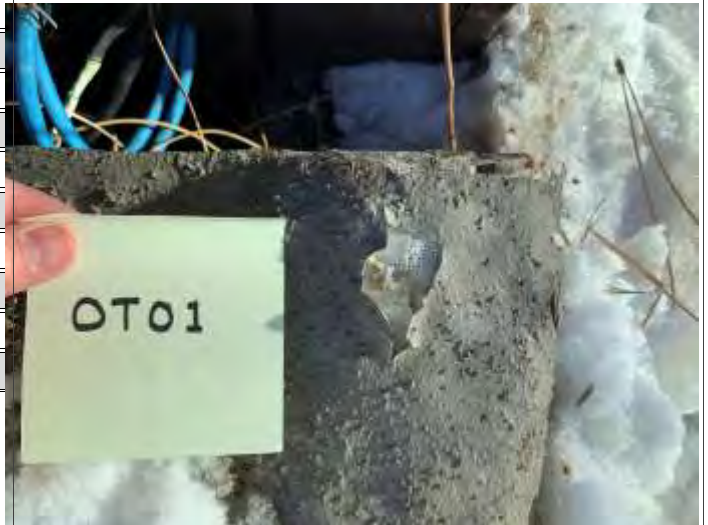
HOMOGENOUS MATERIAL DESCRIPTION		
OTHER		
CODE	SEQUENCE	SIZE
OT	01	N/A
COLOR	PATTERN/TEXTURE	ASSOCIATED MAT.
White Compound	Woven Cloth	Cover
QUANTITY	MATERIAL TYPE	FRIABLE
20	M	F
CONDITION	DISTURBANCE	ASSESSMENT CAT.
G	L	N/A
MATERIAL NOTES

SAMPLE NUMBER	SAMPLE LOCATION DESCRIPTION	ANALYTICAL RESULT
K2-Exterior-OT01-01	East Side, 1' from Northeast Corner, 1' Above Ground	None Detected
K2-Exterior-OT01-02	East Side, 3' from Northeast Corner, 1' Above Ground	None Detected

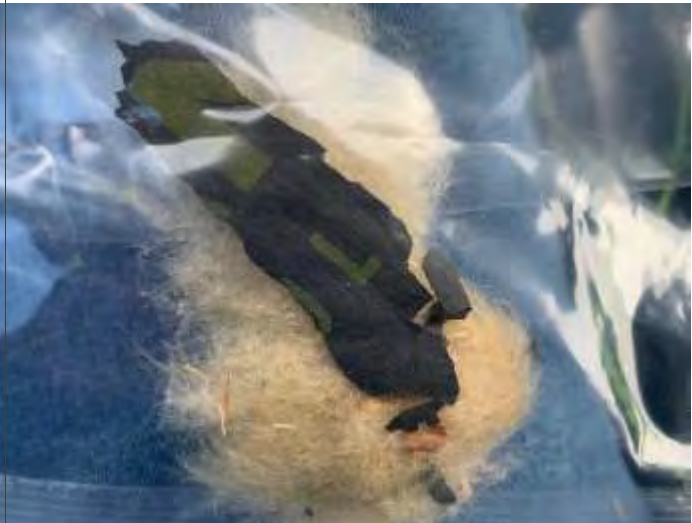
HOMOGENOUS MATERIAL DESCRIPTION		
Paper/Felt, Misc.		
CODE	SEQUENCE	SIZE
PFM	01	N/A
COLOR	PATTERN/TEXTURE	ASSOCIATED MAT.
Black Paper	Fibrous	Yellow Fiberglass
QUANTITY	MATERIAL TYPE	FRIABLE
55	M	F
CONDITION	DISTURBANCE	ASSESSMENT CAT.
G	L	N/A
MATERIAL NOTES

SAMPLE NUMBER	SAMPLE LOCATION DESCRIPTION	ANALYTICAL RESULT
K2-Interior-PFM01-01	2' from South Wall, 4' from East Wall, 8' Above Floor	None Detected
K2-Interior-PFM01-02	2' from South Wall, 4' from East Wall, 8' Above Floor	None Detected

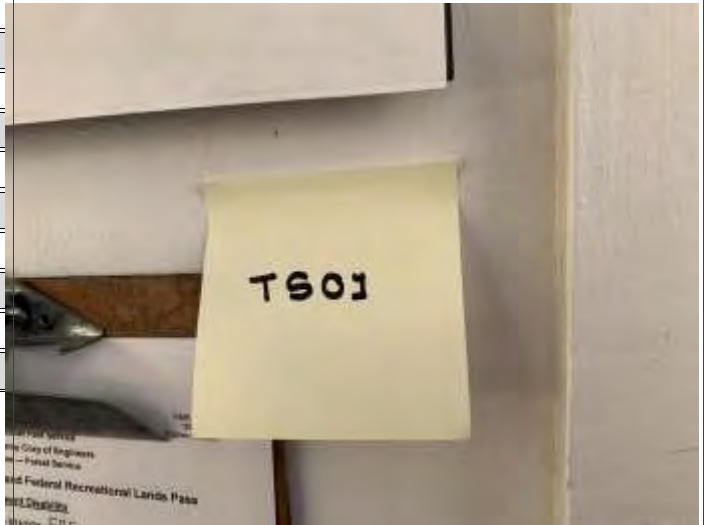
HOMOGENOUS MATERIAL DESCRIPTION		
Textured Surfacing		
CODE	SEQUENCE	SIZE
TS	01	N/A
COLOR	PATTERN/TEXTURE	ASSOCIATED MAT.
White Compound		
QUANTITY	MATERIAL TYPE	FRIABLE
311	S	F
CONDITION	DISTURBANCE	ASSESSMENT CAT.
G	L	N/A
MATERIAL NOTES

SAMPLE NUMBER	SAMPLE LOCATION DESCRIPTION	ANALYTICAL RESULT
K2-Interior-TS01-01	Interior Ceiling, 1' from South Wall, 3' from West Wall	None Detected
K2-Interior-TS01-02	North Wall, 2' from West Wall, 4' Above Floor	None Detected
K2-Interior-TS01-03	South Wall, 2' from West Wall, 4' Above Floor	None Detected

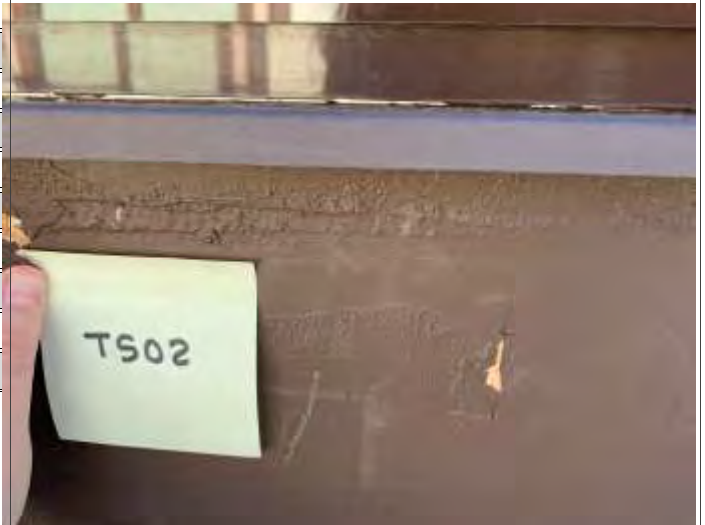
HOMOGENOUS MATERIAL DESCRIPTION		
Textured Surfacing		
CODE	SEQUENCE	SIZE
TS	02	N/A
COLOR	PATTERN/TEXTURE	ASSOCIATED MAT.
White	Woven Cloth	North Façade
QUANTITY	MATERIAL TYPE	FRIABLE
1	S	F
CONDITION	DISTURBANCE	ASSESSMENT CAT.
G	L	N/A
MATERIAL NOTES

SAMPLE NUMBER	SAMPLE LOCATION DESCRIPTION	ANALYTICAL RESULT
K2-Exterior-TS02-01	North Façade, 2' from Northwest Corner, 4' Above Ground	None Detected
K2-Exterior-TS02-02	North Façade, 3' from Northwest Corner, 4' Above Ground	None Detected
K2-Exterior-TS02-03	North Façade, 4' from Northwest Corner, 4' Above Ground	None Detected

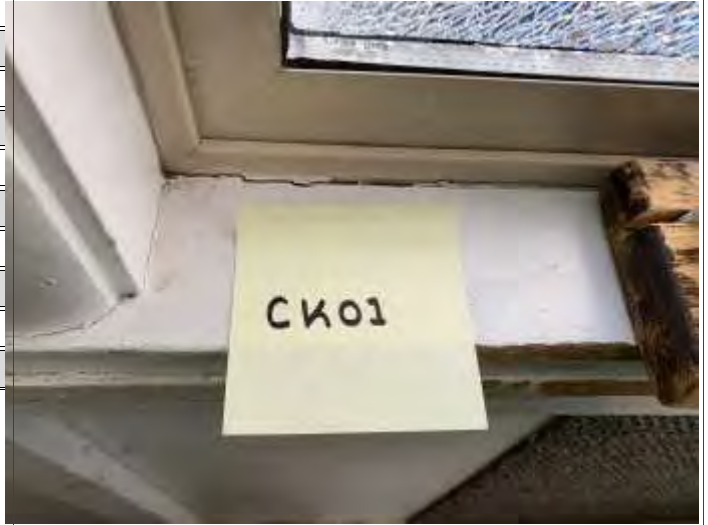
HOMOGENOUS MATERIAL DESCRIPTION		
Caulking (interior/exterior)		
CODE	SEQUENCE	SIZE
CK	01	N/A
COLOR	PATTERN/TEXTURE	ASSOCIATED MAT.
Off-White Grey	Brittle	Interior Windows
QUANTITY	MATERIAL TYPE	FRIABLE
20	M	F
CONDITION	DISTURBANCE	ASSESSMENT CAT.
G	L	N/A
MATERIAL NOTES

SAMPLE NUMBER	SAMPLE LOCATION DESCRIPTION	ANALYTICAL RESULT
K3-Interior-CK01-01	North Wall, Below Window, 5' from West Wall, 3.5' Above Floor	None Detected
K3-Interior-CK01-02	North Wall, Below Window, 9' from West Wall, 3.5' Above Floor	None Detected

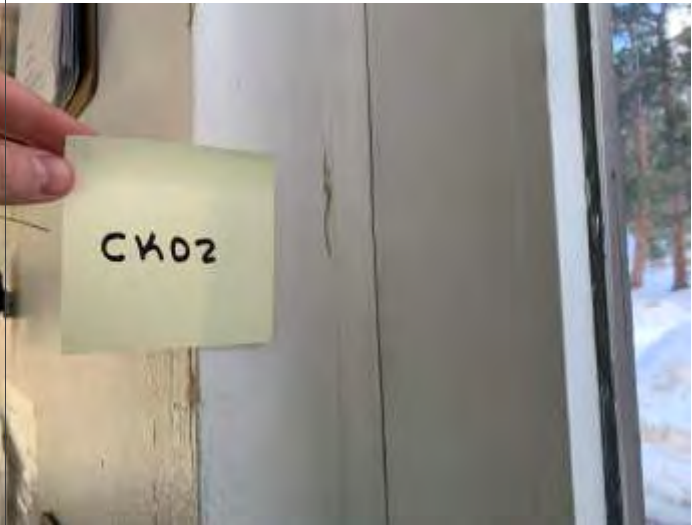
HOMOGENOUS MATERIAL DESCRIPTION		
Caulking (interior/exterior)		
CODE	SEQUENCE	SIZE
CK	02	N/A
COLOR	PATTERN/TEXTURE	ASSOCIATED MAT.
Bright White	Brittle	Interior Doors
QUANTITY	MATERIAL TYPE	FRIABLE
20	M	F
CONDITION	DISTURBANCE	ASSESSMENT CAT.
G	L	N/A
MATERIAL NOTES

SAMPLE NUMBER	SAMPLE LOCATION DESCRIPTION	ANALYTICAL RESULT
K3-Interior-CK02-01	North Wall, West Side of Door Frame, 5' Above Floor	None Detected
K3-Interior-CK02-02	North Wall, East Side of Door Frame, 5' Above Floor	None Detected

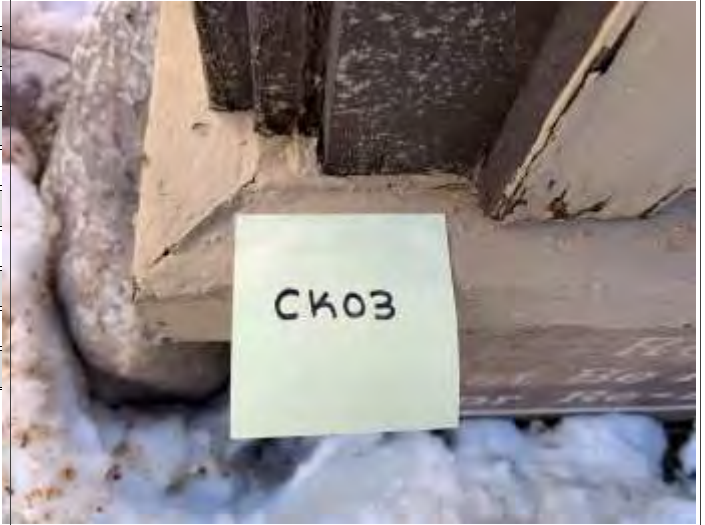
HOMOGENOUS MATERIAL DESCRIPTION		
Caulking (interior/exterior)		
CODE	SEQUENCE	SIZE
CK	03	N/A
COLOR	PATTERN/TEXTURE	ASSOCIATED MAT.
Bright White	Brittle	Exterior Façade
QUANTITY	MATERIAL TYPE	FRIABLE
36	M	F
CONDITION	DISTURBANCE	ASSESSMENT CAT.
G	L	N/A
MATERIAL NOTES

SAMPLE NUMBER	SAMPLE LOCATION DESCRIPTION	ANALYTICAL RESULT
K3-Exterior-CK03-01	North Wall, at Northeast Corner, 3' Above Ground	None Detected
K3-Exterior-CK03-02	South Wall, 3' from Southwest Corner, 3' Above Ground	None Detected
K3-Exterior-CK03-03	South Wall, 3.5' from Southwest Corner, 3' Above Ground (Quality Control)	None Detected

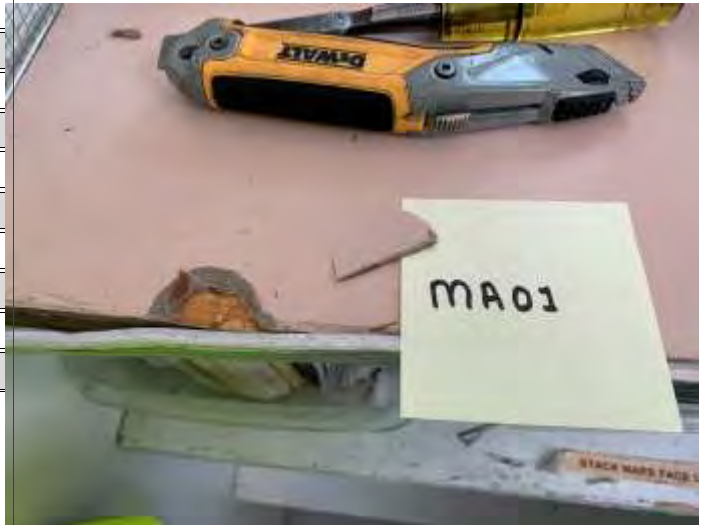
HOMOGENOUS MATERIAL DESCRIPTION		
Adhesive/Mastic, Misc.		
CODE	SEQUENCE	SIZE
MA	01	N/A
COLOR	PATTERN/TEXTURE	ASSOCIATED MAT.
Clear Brown		Pink Countertop
QUANTITY	MATERIAL TYPE	FRIABLE
20	M	NF II
CONDITION	DISTURBANCE	ASSESSMENT CAT.
G	L	N/A
MATERIAL NOTES

SAMPLE NUMBER	SAMPLE LOCATION DESCRIPTION	ANALYTICAL RESULT
K3-Interior-MA01-01	West Countertop, 6" from South Wall, 2' from West Wall, 3.5' Above Floor	None Detected
K3-Interior-MA01-02	East Countertop, 6" from South Wall, 2.5' from East Wall, 3.5' Above Floor	None Detected

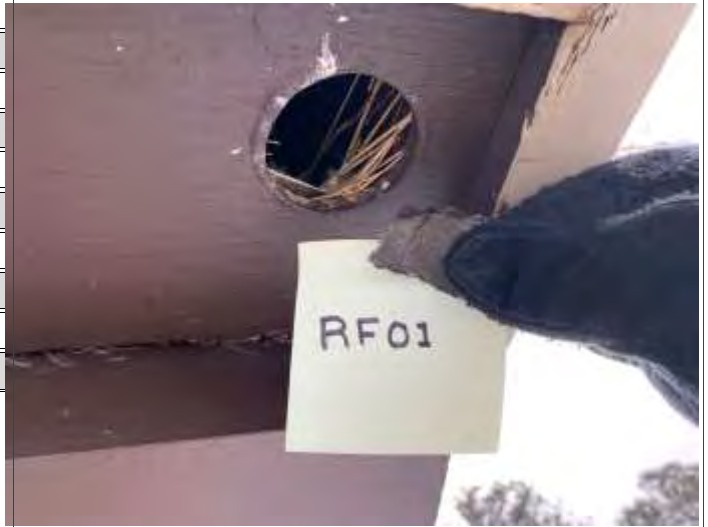
HOMOGENOUS MATERIAL DESCRIPTION		
Roofing Felt		
CODE	SEQUENCE	SIZE
RF	01	N/A
COLOR	PATTERN/TEXTURE	ASSOCIATED MAT.
Black	Soft	Wood Shingles
QUANTITY	MATERIAL TYPE	FRIABLE
72	M	F
CONDITION	DISTURBANCE	ASSESSMENT CAT.
G	L	N/A
MATERIAL NOTES

SAMPLE NUMBER	SAMPLE LOCATION DESCRIPTION	ANALYTICAL RESULT
K3-Roof-RF01-01	Northwest Corner, 8' Above Ground	None Detected
K3-Roof-RF01-02	Southeast Corner, 8' Above Ground	None Detected

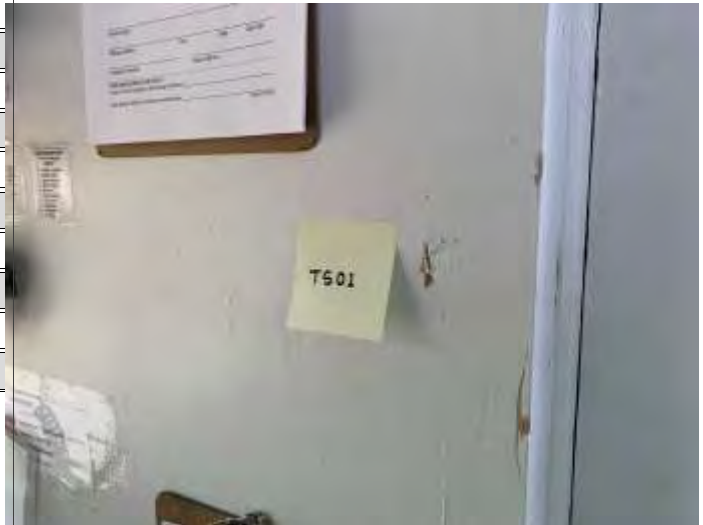
HOMOGENOUS MATERIAL DESCRIPTION		
Textured Surfacing		
CODE	SEQUENCE	SIZE
TS	01	N/A
COLOR	PATTERN/TEXTURE	ASSOCIATED MAT.
Bright White		Walls Ceilings
QUANTITY	MATERIAL TYPE	FRIABLE
311	S	F
CONDITION	DISTURBANCE	ASSESSMENT CAT.
G	L	N/A
MATERIAL NOTES

SAMPLE NUMBER	SAMPLE LOCATION DESCRIPTION	ANALYTICAL RESULT
K3-Interior-TS01-01	North Wall, 2.5' from West Wall, 5' Above Floor	None Detected
K3-Interior-TS01-02	South Wall, 2.5' from West Wall, 5' Above Floor	None Detected
K3-Interior-TS01-03	Ceiling, 1' from North Wall, 3' from West Wall, 8' Above Floor	None Detected

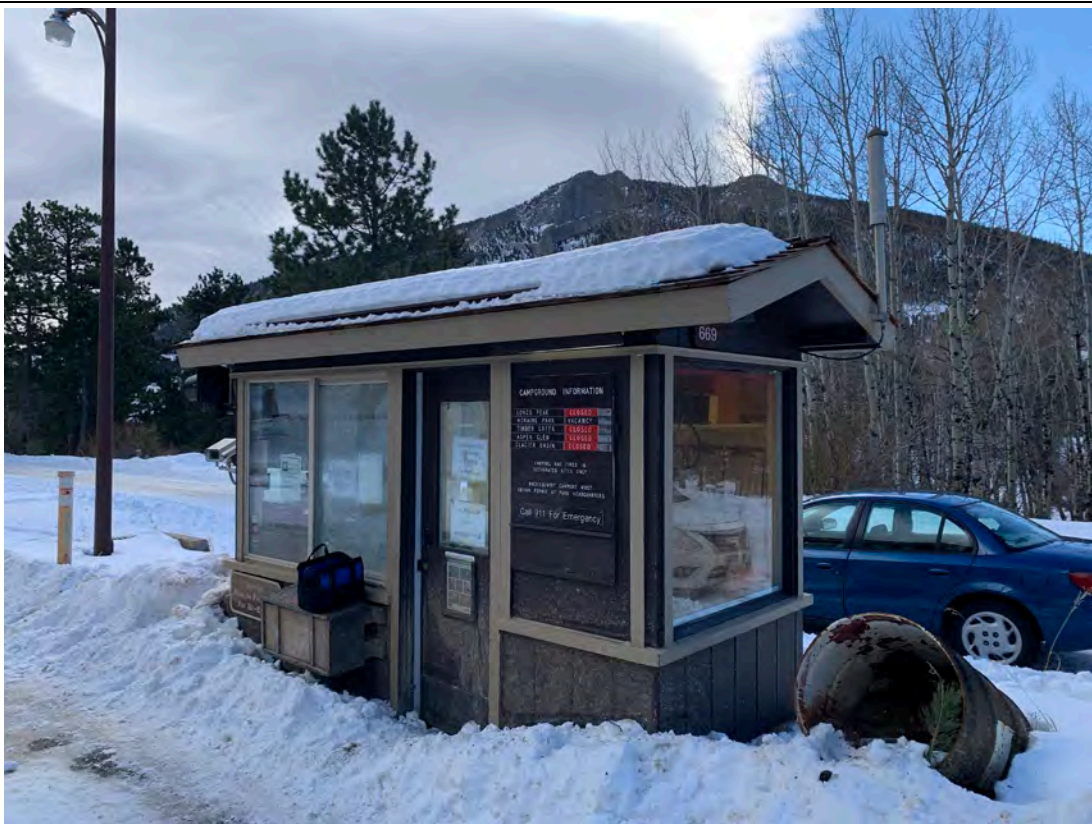
<b>LANDMARK Project No.</b> 21115.001.001	<b>Description</b>	Front exterior of Kiosk 3 building structure, looking to the southeast.	<b>Photo 1</b>
	<b>Site Name</b>	Rocky Mountain National Park – Fall River Entrance Station Kiosk 3	<b>Photo Date</b> 01/11/2022

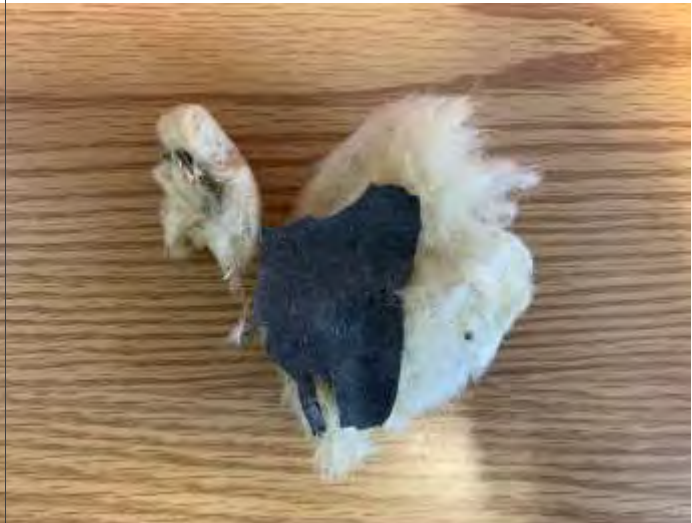
HOMOGENOUS MATERIAL DESCRIPTION		
Paper/Felt, Misc.		
CODE	SEQUENCE	SIZE
PFM	01	N/A
COLOR	PATTERN/TEXTURE	ASSOCIATED MAT.
Black Paper	Fibrous	Yellow Fiberglass
QUANTITY	MATERIAL TYPE	FRIABLE
188.25	M	F
CONDITION	DISTURBANCE	ASSESSMENT CAT.
G	L	N/A
MATERIAL NOTES

SAMPLE NUMBER	SAMPLE LOCATION DESCRIPTION	ANALYTICAL RESULT
O-Office-PFM01-01	4.5' from East Wall, 2' from South Wall, 8' Above Floor	None Detected
O-Office-PFM01-02	4.5' from East Wall, 2' from South Wall, 8' Above Floor	None Detected

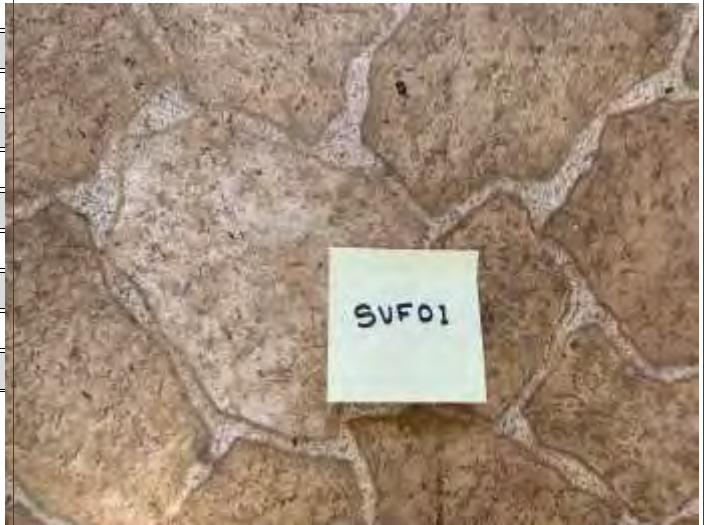
HOMOGENOUS MATERIAL DESCRIPTION		
Sheet Vinyl Flooring		
CODE	SEQUENCE	SIZE
SVF	01	N/A
COLOR	PATTERN/TEXTURE	ASSOCIATED MAT.
Tan Grey Paper	Pebbles	Yellow Glue
QUANTITY	MATERIAL TYPE	FRIABLE
18	M	F
CONDITION	DISTURBANCE	ASSESSMENT CAT.
G	L	N/A
MATERIAL NOTES

SAMPLE NUMBER	SAMPLE LOCATION DESCRIPTION	ANALYTICAL RESULT
O-Bath-SVF01-01	Northwest Corner of Bathroom	None Detected
O-Bath-SVF01-02	South Door Threshold, 2' from East Wall	None Detected

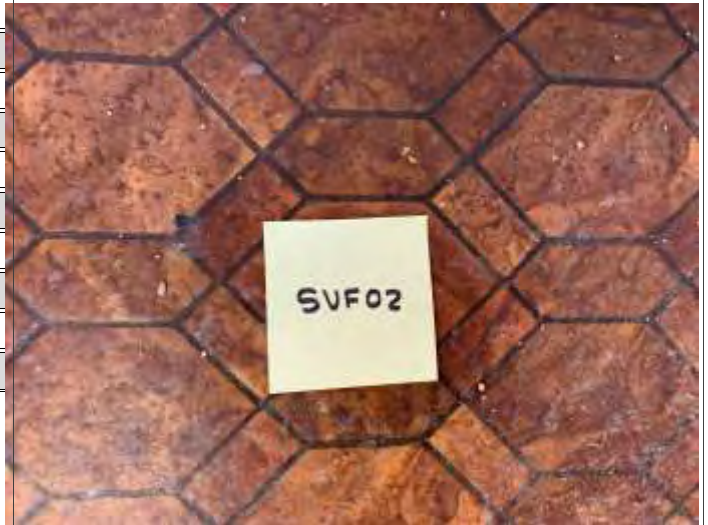
HOMOGENOUS MATERIAL DESCRIPTION		
Sheet Vinyl Flooring		
CODE	SEQUENCE	SIZE
SVF	02	N/A
COLOR	PATTERN/TEXTURE	ASSOCIATED MAT.
Red Brown	Diamonds	Grey Felt
QUANTITY	MATERIAL TYPE	FRIABLE
119	M	F
CONDITION	DISTURBANCE	ASSESSMENT CAT.
G	L	N/A
MATERIAL NOTES

SAMPLE NUMBER	SAMPLE LOCATION DESCRIPTION	ANALYTICAL RESULT
O-Office-SVF02-01	At North Door Threshold to Closet, 6' from West Wall	None Detected
O-Office-SVF02-02	At South Wall, 3' from East Wall	None Detected

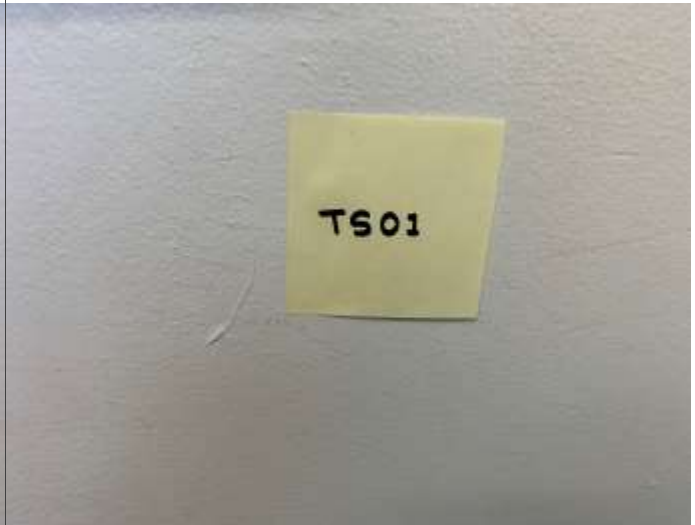
HOMOGENOUS MATERIAL DESCRIPTION		
Textured Surfacing		
CODE	SEQUENCE	SIZE
TS	01	N/A
COLOR	PATTERN/TEXTURE	ASSOCIATED MAT.
White Compound		
QUANTITY	MATERIAL TYPE	FRIABLE
756.25	S	F
CONDITION	DISTURBANCE	ASSESSMENT CAT.
G	L	N/A
MATERIAL NOTES

SAMPLE NUMBER	SAMPLE LOCATION DESCRIPTION	ANALYTICAL RESULT
O-Bath-TS01-01	East Wall, 2.5' from North Wall, 4' Above Floor	None Detected
O-Bath-TS01-02	South Wall, 6" from West Side of South Doorway, 4.5' Above Floor	None Detected
O-Office-TS01-03	North Wall, 6" from West Side of North Doorway, 4.5' Above Floor	None Detected
O-Office-TS01-04	South Wall, 4' from East Wall, 3' Above Floor	None Detected
O-Office-TS01-05	North Wall, 11' from West Wall, 2' Above Floor	None Detected

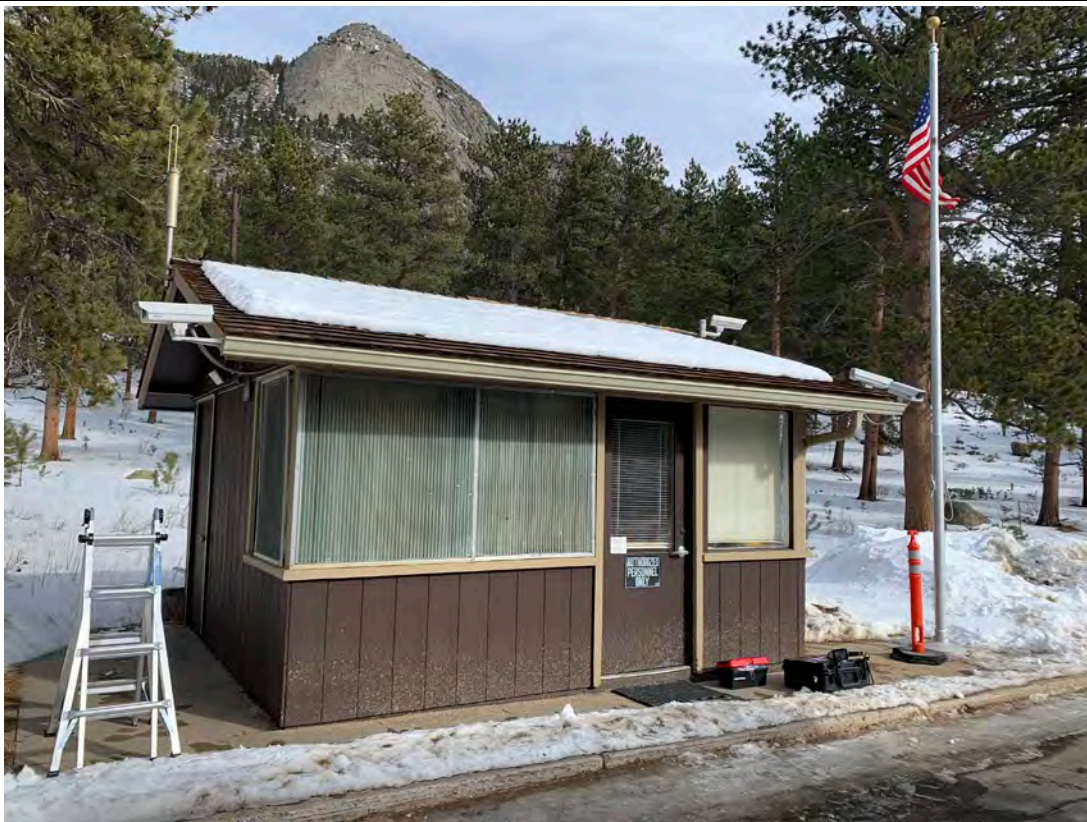
<b>LANDMARK Project No.</b> 21115.001.001	<b>Description</b>	Front entrance of the office building structure, looking to the northeast.	<b>Photo 1</b>
	<b>Site Name</b>	Rocky Mountain National Park – Fall River Entrance Station Office	<b>Photo Date</b> 01/12/2022
