Management Report

Air National Guard
Bldg 112
765 n 2200 W, Salt Lake City, UT

Prepared For
Air National Guard

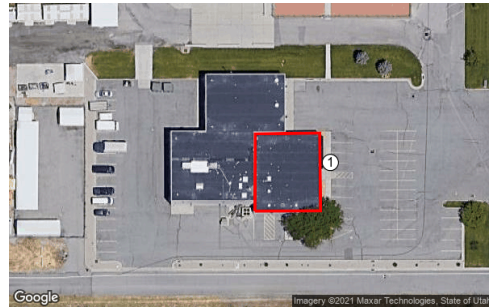
Summary

**Condition Summary**

Membrane: F
Flashings: F
Sheet Metal: F

Overall: F

The roof has passed its service life and is beyond repair. Due to the age of this roof and UV rays from the sun, the protective layer of the roof has deteriorated leaving the bare membrane exposed and damaged. Unfortunately, due to the severity of the roof condition, the insulation is not salvageable and will require a full tear-off and re-roof to ensure no more water intrusion into the building.

Estimated Replacement: 2021

The only acceptable repair would be to apply 2-3 layers of a rubberized coating in the field and on all wall and curb flashing. If a repair were to be performed, it strictly to maintain the roof through coming winter season.

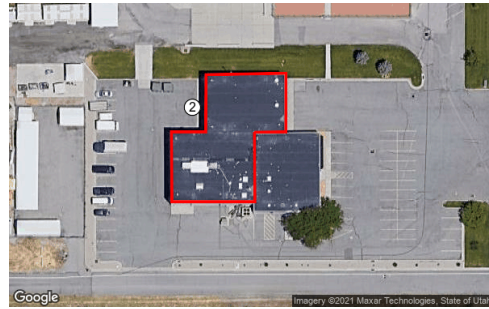
Condition Summary

Membrane: F
 Flashings: F
 Sheet Metal: F

The roof has passed its service life and is beyond repair. Due to the age of this roof and UV rays from the sun, the protective layer of the roof has deteriorated leaving the bare membrane exposed and damaged. Unfortunately, due to the severity of the roof condition, the insulation is not salvageable and will require a full tear-off and re-roof to ensure no more water intrusion into the building.

Estimated Replacement: 2021

The only acceptable repair would be to apply 2-3 layers of a rubberized coating in the field and on all wall and curb flashing. If a repair were to be performed, it strictly to maintain the roof through coming winter season.
